## Space Shuttle Boundary Layer Transition Flight Experiment Overview

Thermal & Fluids Analysis Workshop

TFAWS 2012

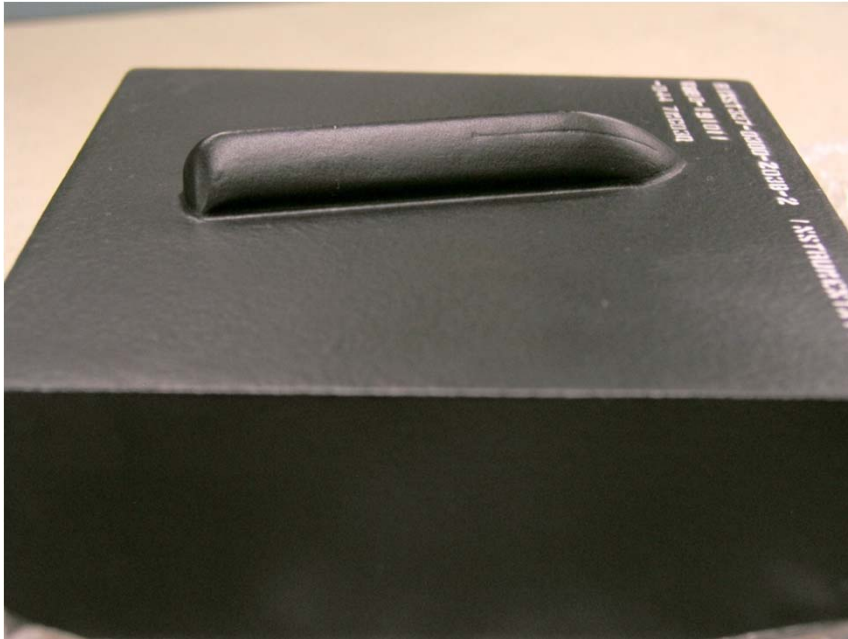
- Incremental approach to flight test for safety
- Protuberance height derived with RTF BLT tool
  - $Re_\theta/M_e$  correlation using best estimate coefficient
  - First flight: 0.25 inches (~Mach 15)
  - Second/Third flights: 0.35 inches (~Mach 18)
  - Fourth/Fifth flights: 0.50 inches (~Mach 19.2)

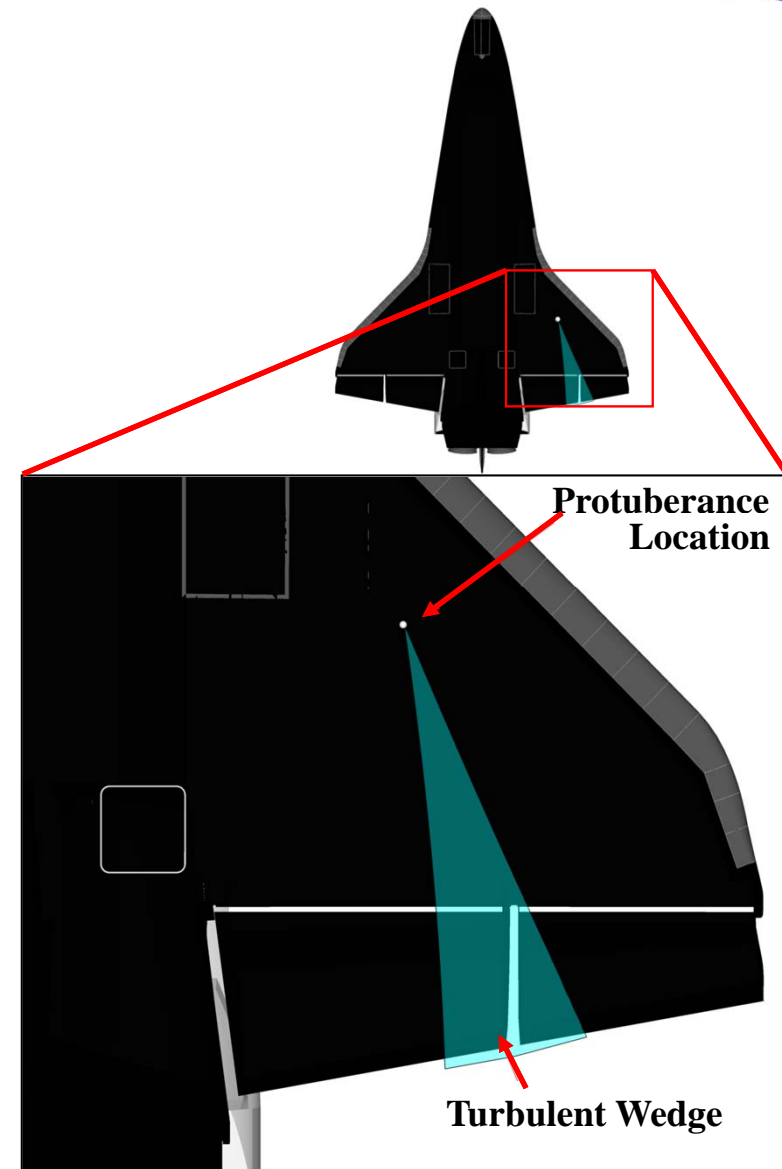
- Top design constraint for flight experiment was safety
- Region of turbulent flow (aka, turbulent “wedge”) downstream of surface disturbance causing boundary layer transition
- Protuberance placement based on:
  - Instrumentation channels/wiring
  - Ascent debris: some areas less prone to damage
  - TPS/Structural margins: turbulent wedge heating can reduce TPS/structural capabilities
- Analysis results showed risk of critical damage within wedge < 1:10,000

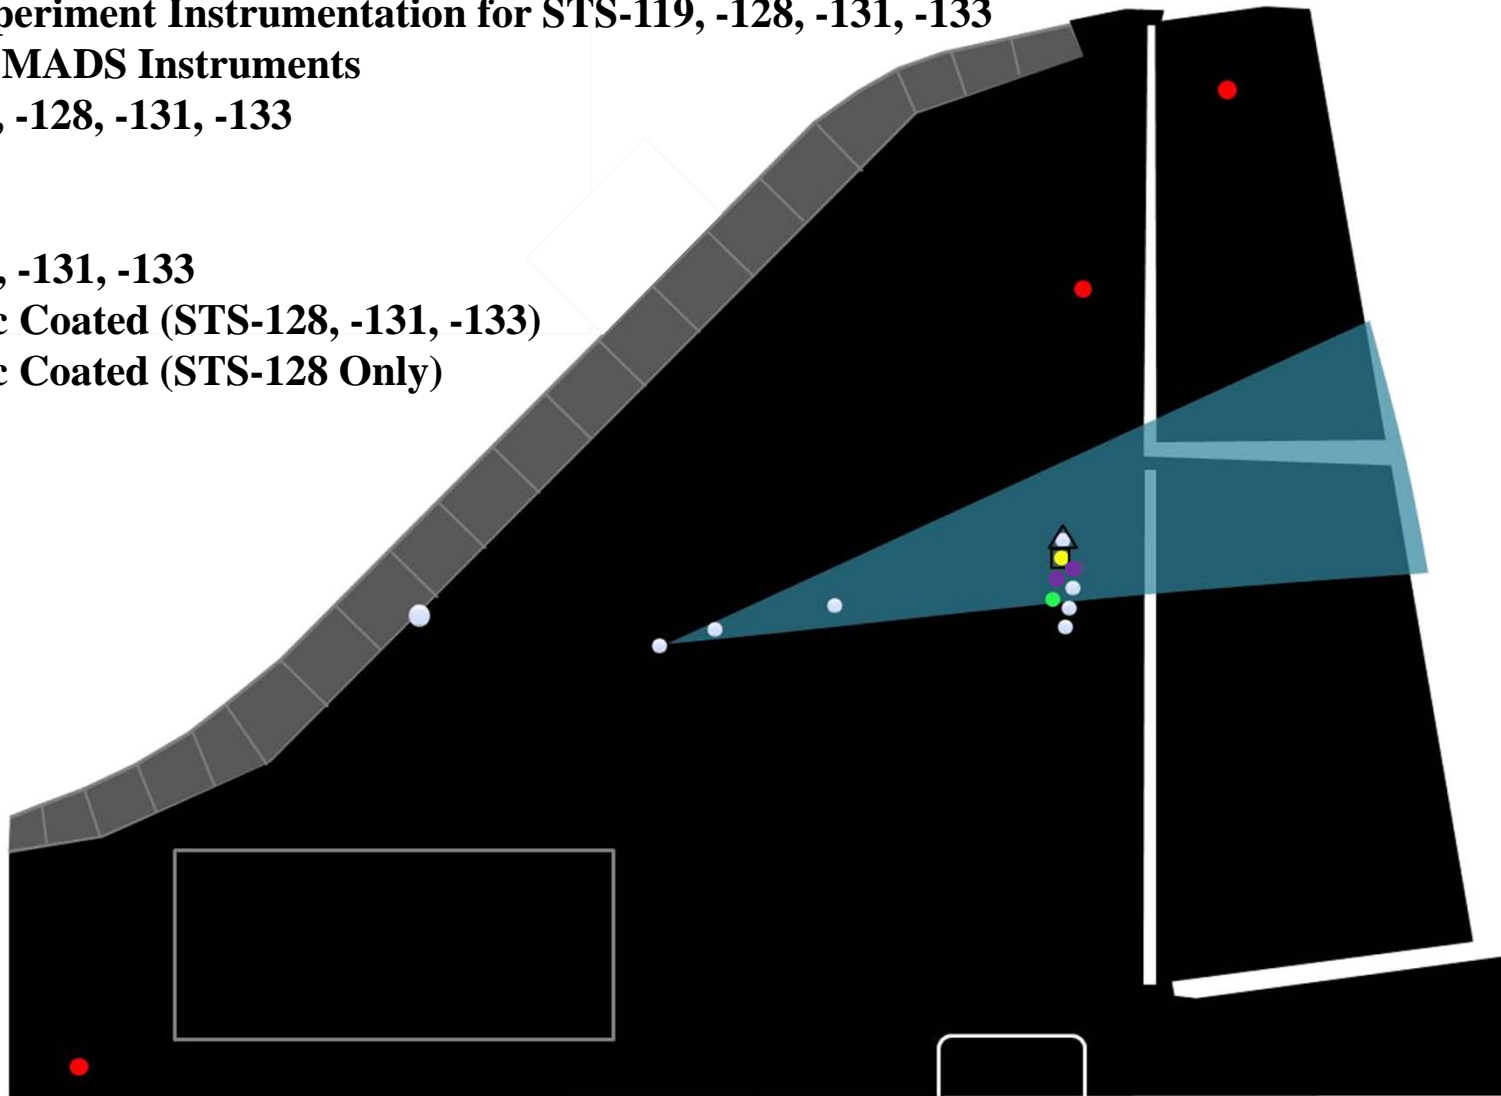
## Flight Experiment Instrumentation for STS-119, -128, -131, -133

- Existing MADS Instruments
- STS-119, -128, -131, -133
- STS-119
- STS-128
- STS-128, -131, -133
- Catalytic Coated (STS-128, -131, -133)
- △ Catalytic Coated (STS-128 Only)

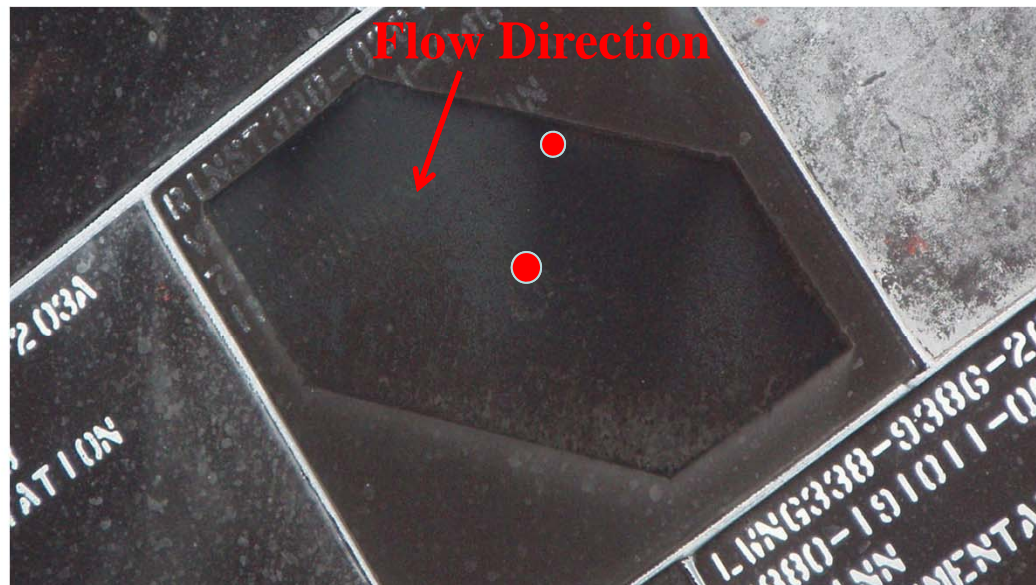
- Complementary test performed to study coupling behavior of catalytic material in fully turbulent flow
  - Results could aid in design of Orion back shell
- Laminar catalytic behavior studied during STS-2, -3, and -5. BLT relatively late in trajectory
- Fully-catalytic coating material applied to tiles downstream of protuberance in predicted turbulent wedge
  - Coating formulation established/tested based on material use on early flight tests
  - Applied on STS-128, 131, 133 and 134

● Approximate thermocouple locations

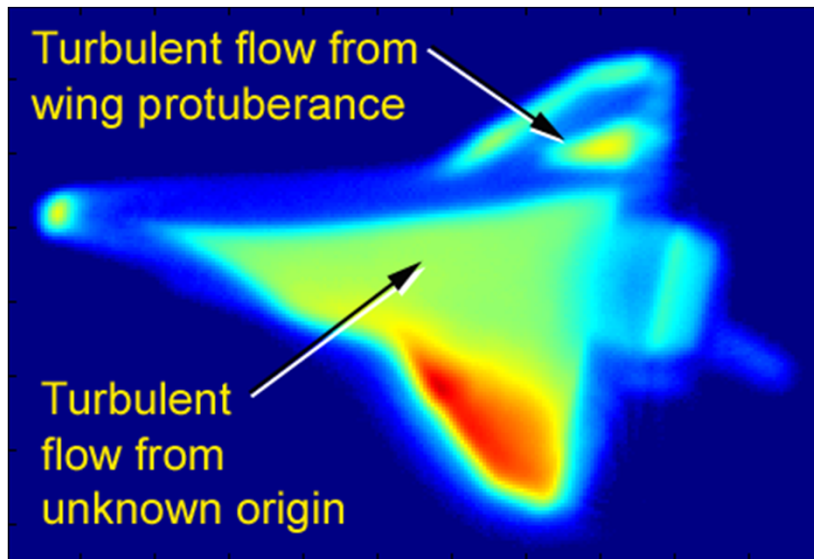
### STS-119

- Earliest BLT onset: Mach 15.6
  - Prediction: Mach 15.4
- Maximum measured protuberance temperature: 2012°F
  - Prediction: ~2900°F

- Cause of temperature over-prediction unknown.
- ~1 month to review data, revise models, perform adequately rigorous analysis
- Ad-hoc approach developed to force combination of engineering and CFD analyses to match STS-119 flight data using “knock down” factors

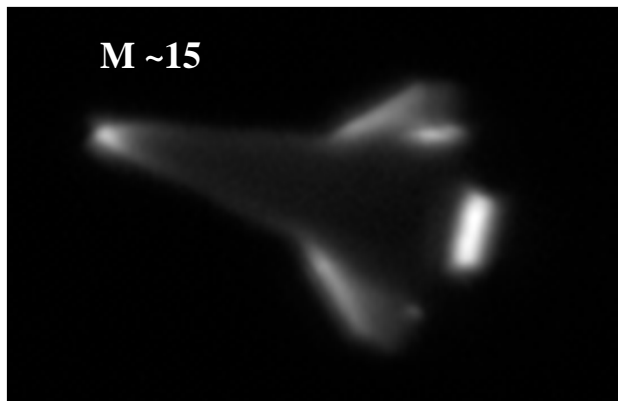
## STS-128

- Earliest BLT onset: Mach 17.5
  - Prediction: Mach 17.4
- Thermocouple anomaly prevented determination of peak laminar temperature
  - Resulted in rapid shift down in data at 350 seconds, same time as roll reversal
  - Seen intermittently on previous shuttle flights, cause unknown

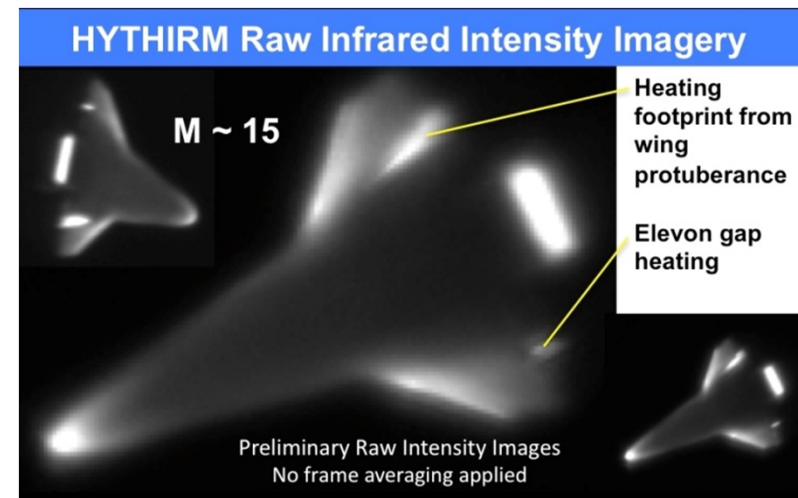
## STS-131

- Earliest BLT onset: Mach 17.4
  - Prediction: Mach 17.2
- Maximum measured protuberance temperature: 2197°F
  - Prediction: ~2650°F

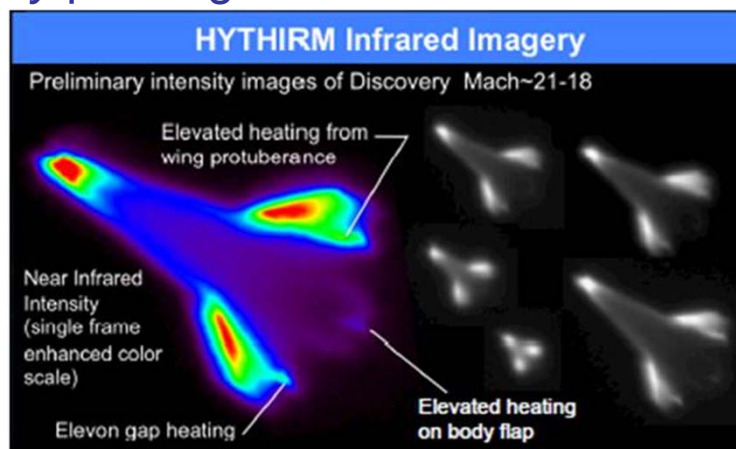
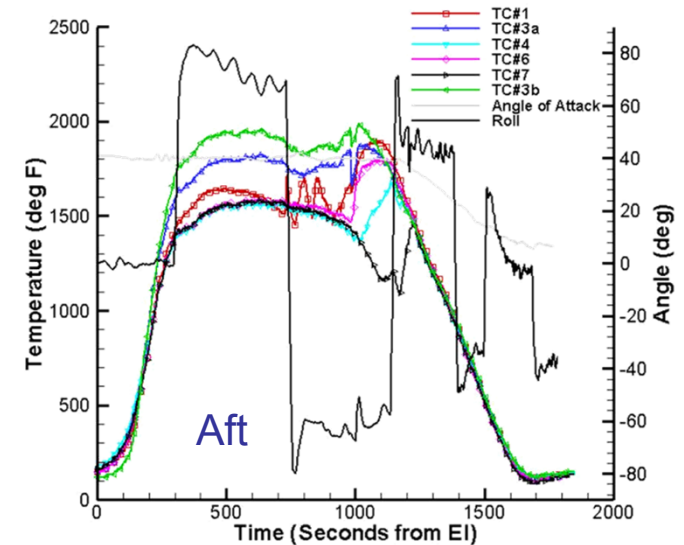
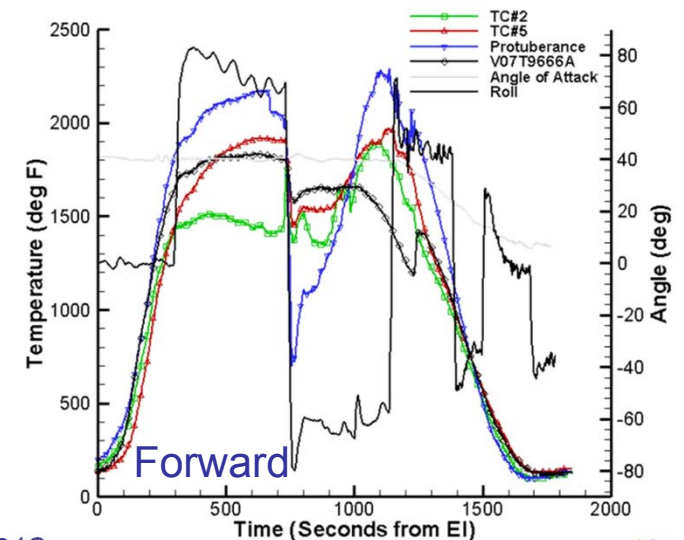
### STS-133

- Earliest BLT onset: Mach 19.6
  - Prediction: Mach 19.2
- Maximum measured protuberance temperature: 2288°F (protuberance BLT Mach 8.3)
  - Prediction: ~2870°F (assumes Mach 13.2 protuberance BLT – pre-flight certification)
  - Prediction: ~2310°F (assumes Mach 8.3 protuberance BLT – post-flight analysis)
- Protuberance and catalytic coating tiles left on *Discovery* post-flight

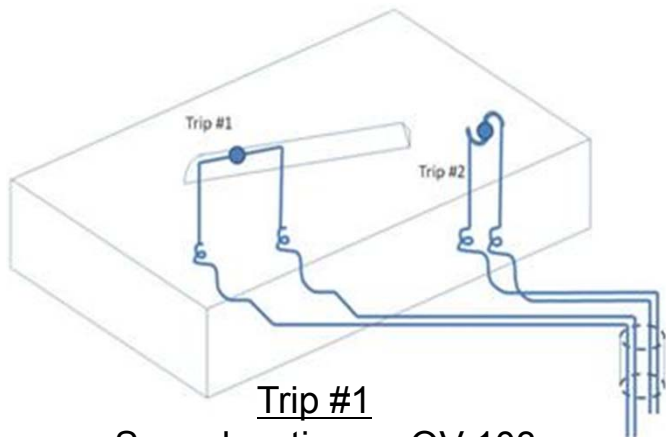
Trip #1

- Same location as OV-103

Trip #2:

- New TC location
- On protuberance tile (but not on protuberance or in vortex)
- S-turn

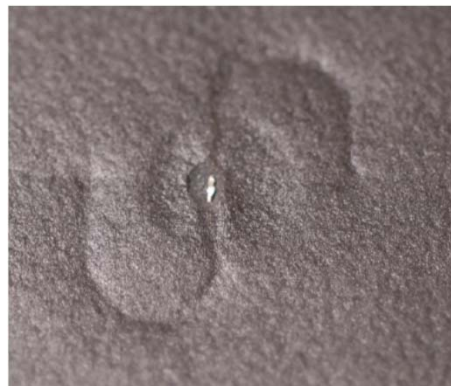
TC #5

- Same location as OV-103
- Exposed TC junction
- S-turn

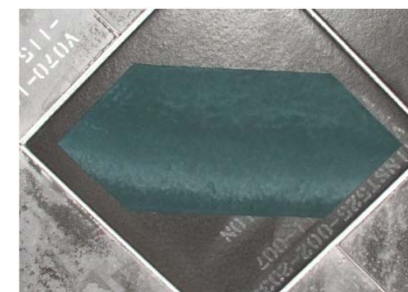
TC #1

- Same location as OV-103
- Catalytic coating

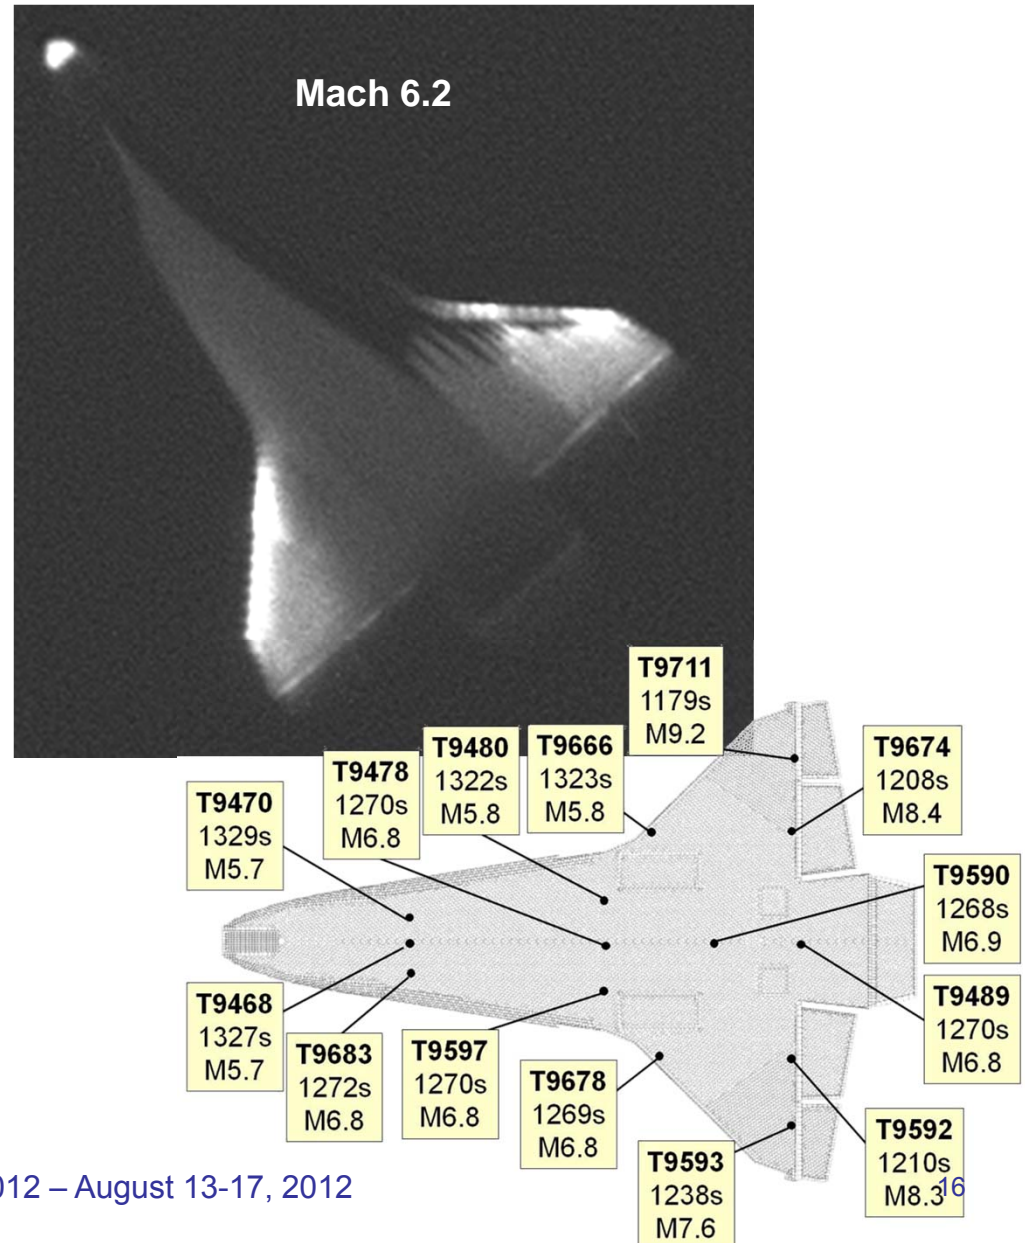
- Launched May 16, 2011
- Landed June 1, 2011 at KSC
- Thermocouple data showed asymmetric BLT over vehicle windward surface
- BLT relatively late over windward surface (~Mach 6-7), indicative of vehicle clean of protruding gap fillers, cavities and/or tile-to-tile steps and gaps
- Reflects significant effort of ground crews to prepare vehicle before flight

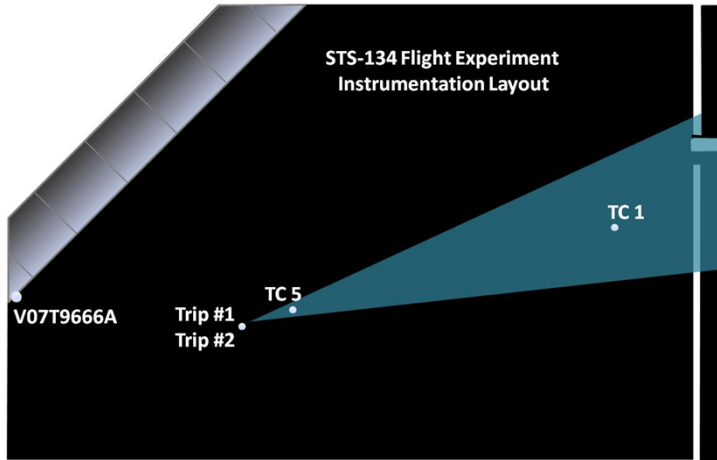
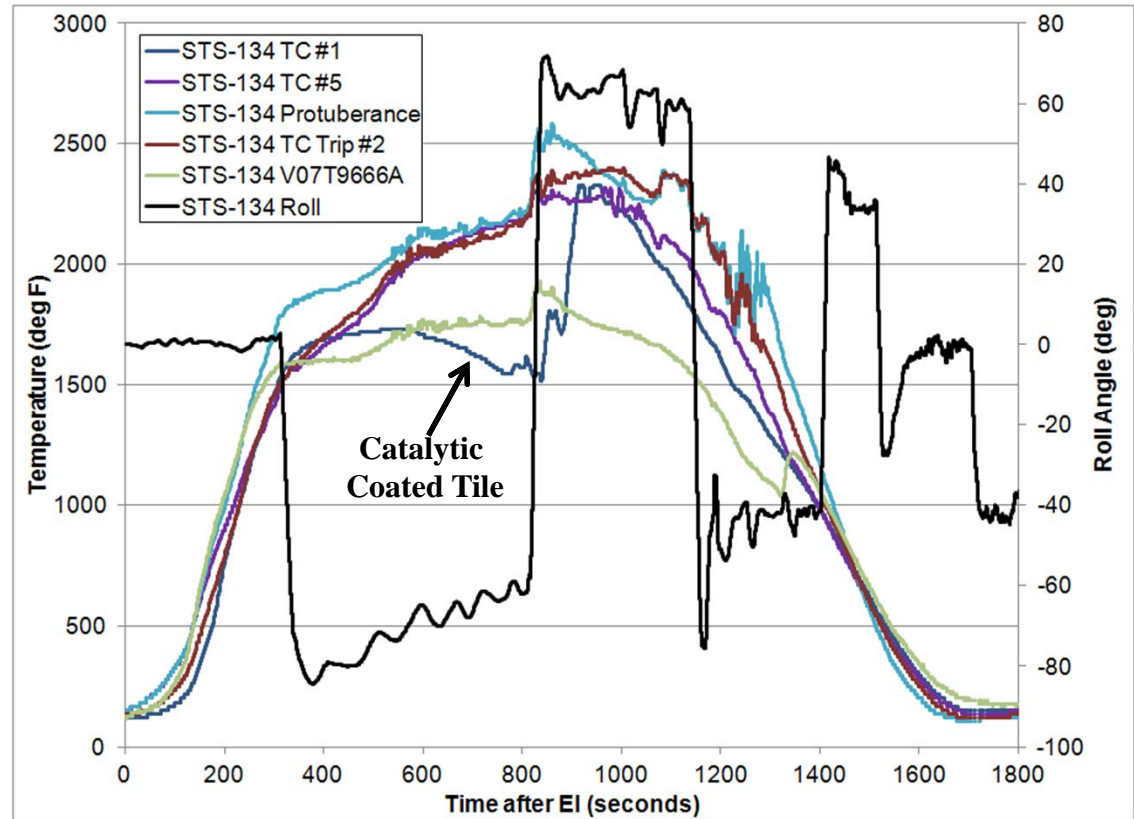
TC	Mach	Time (s)
1	19.6 or 18.6	837 or 879
5	15.4	985
Trip 1	8.0	1227
Trip 2	8.0	1227
V0T9666A	5.9	1323

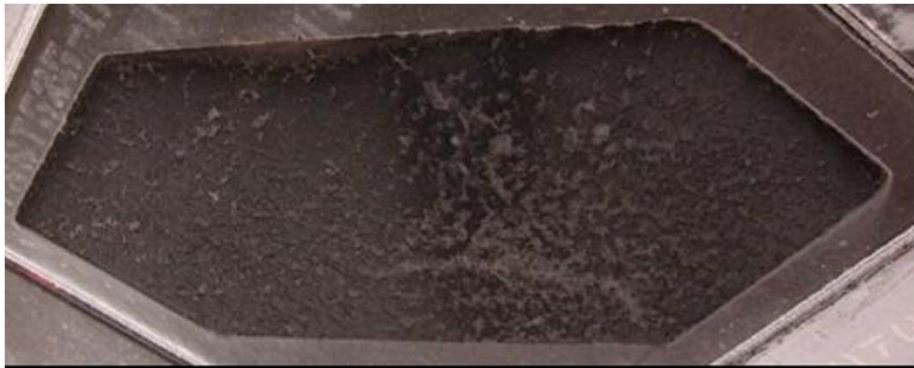
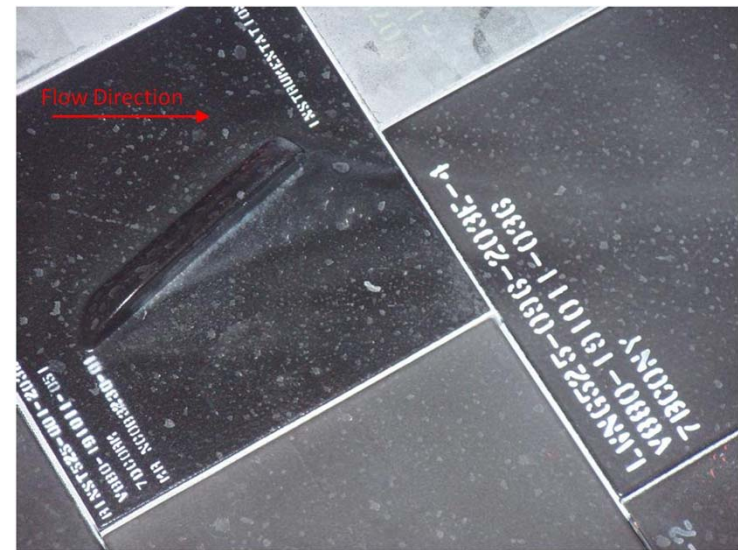
- Earliest BLT onset: Mach 19.6 or 18.6
  - Prediction: Mach 19.2
- Maximum measured protuberance temperature: 2583°F
  - Prediction: ~2800°F
- Temperatures on tile surrounding protuberance did not exceed 2500°F\*
  - Prediction: 2400°F
  - Measured Maximum was 2397°F
- Protuberance and catalytic tiles left on *Endeavour* after the flight

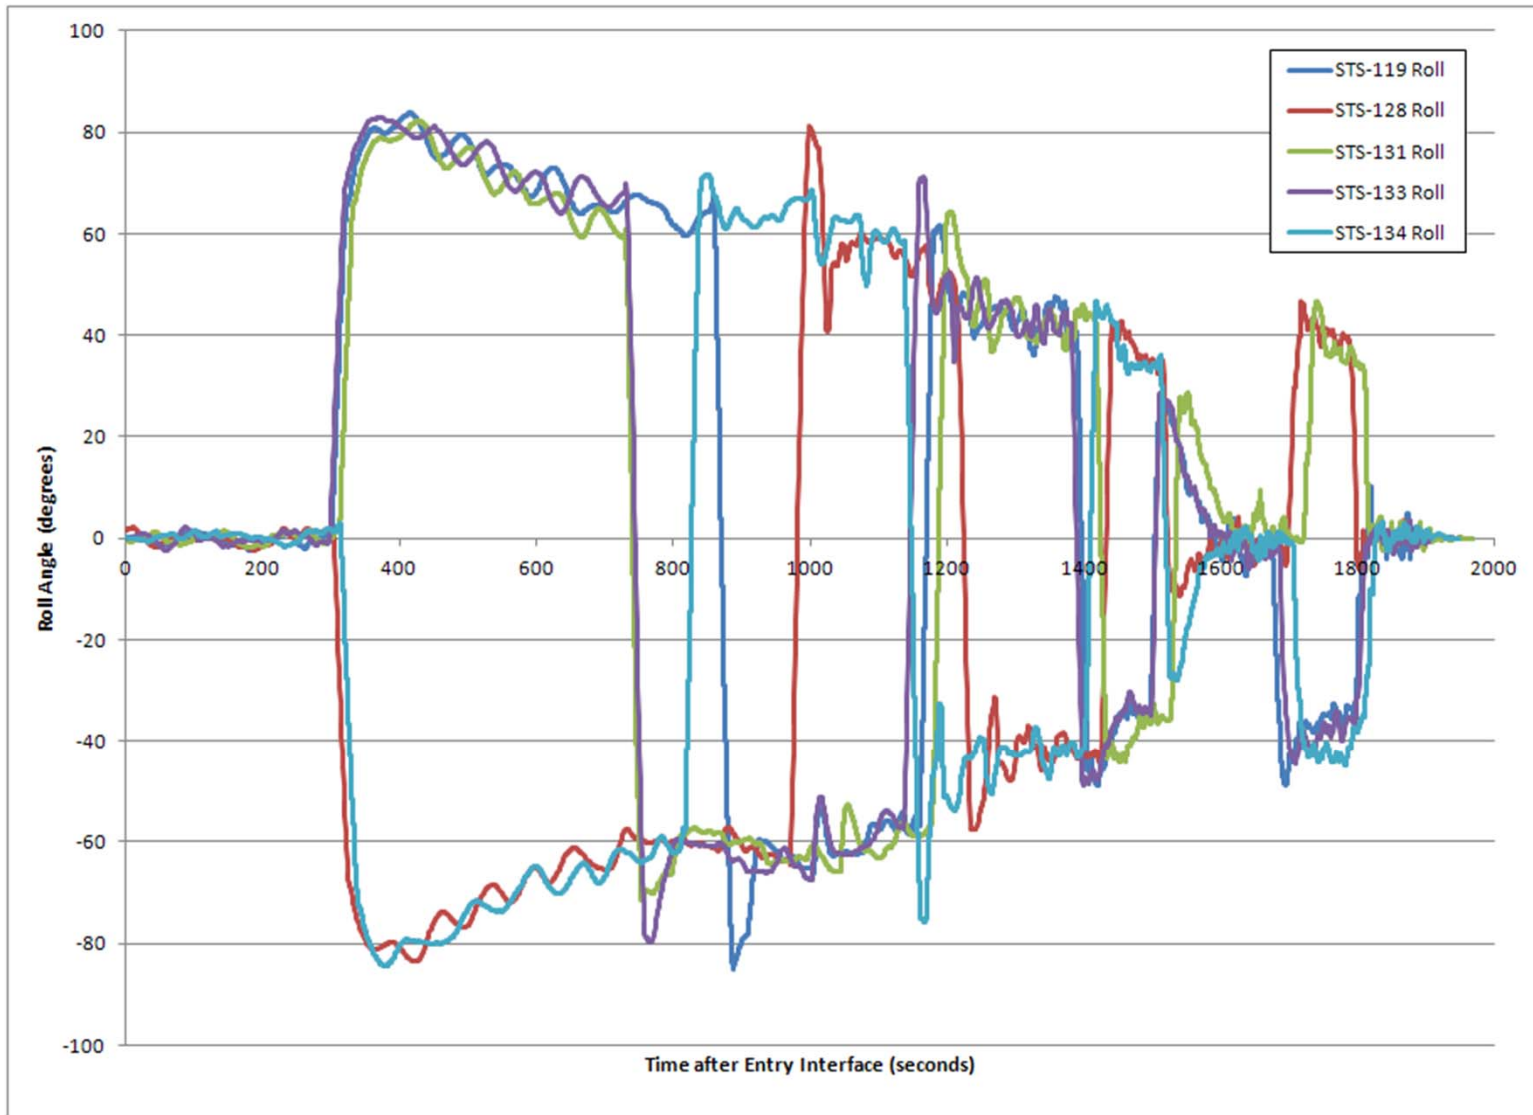
STS-119, STS-131 and STS-133 initially roll positive  
STS-128 and STS-134 initially roll negative

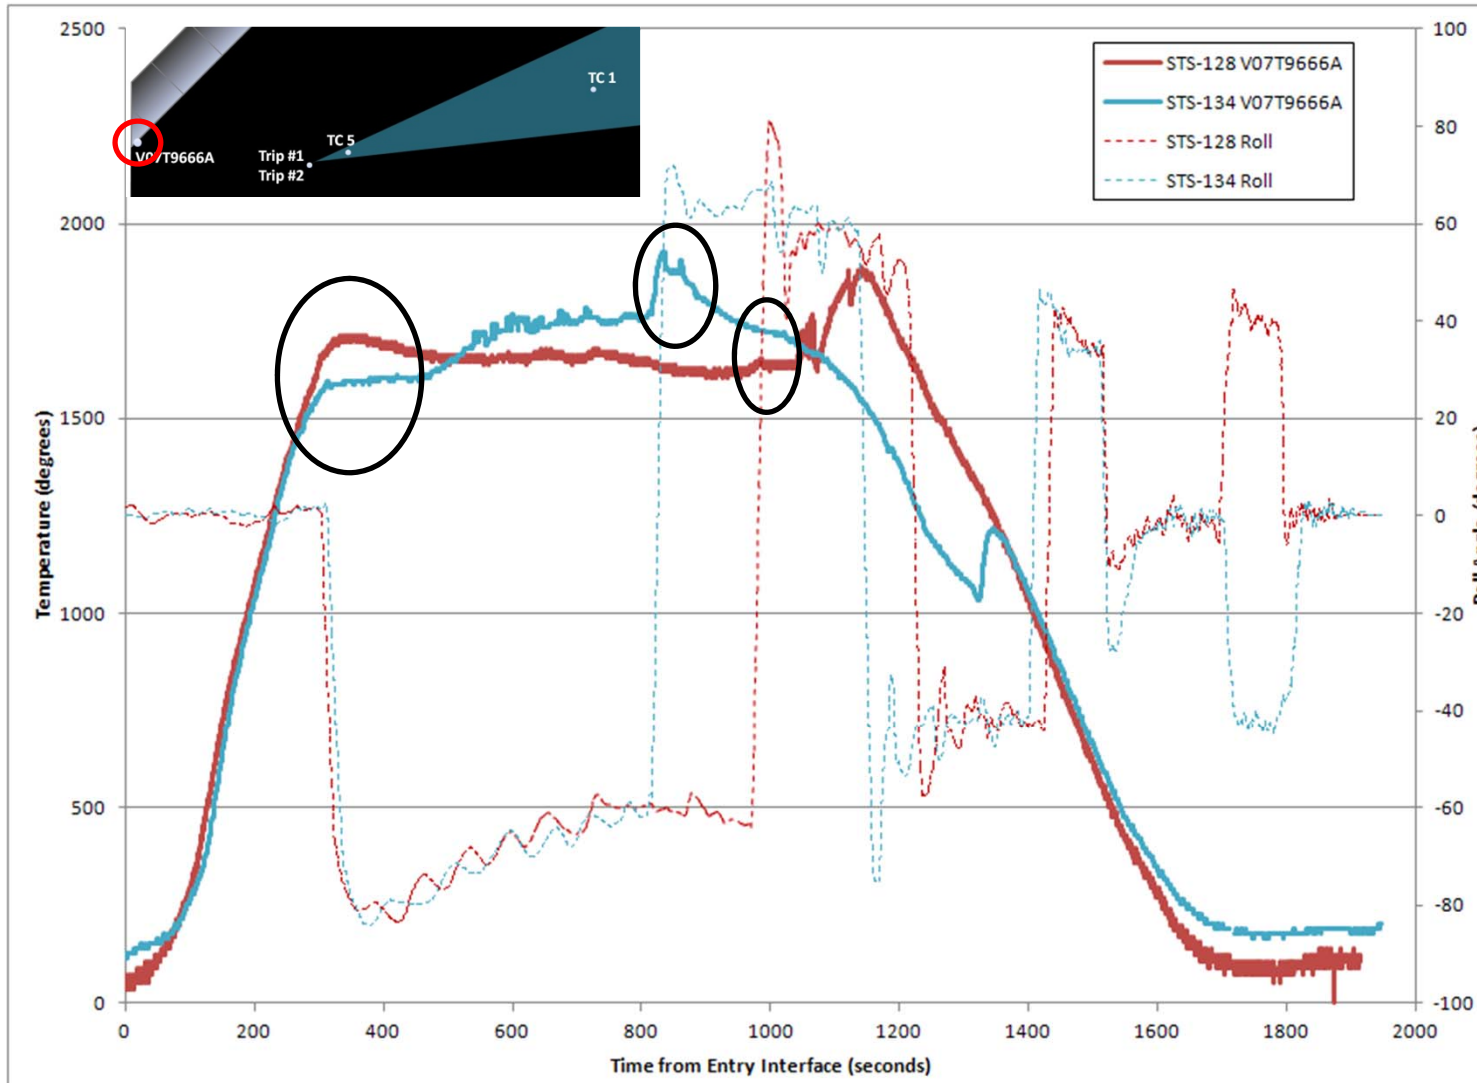
# STS-128 vs. STS-134 (TC9666)

none

Both flights level out at roll onset

Rapid increase for STS-134  
Small increase on STS-128

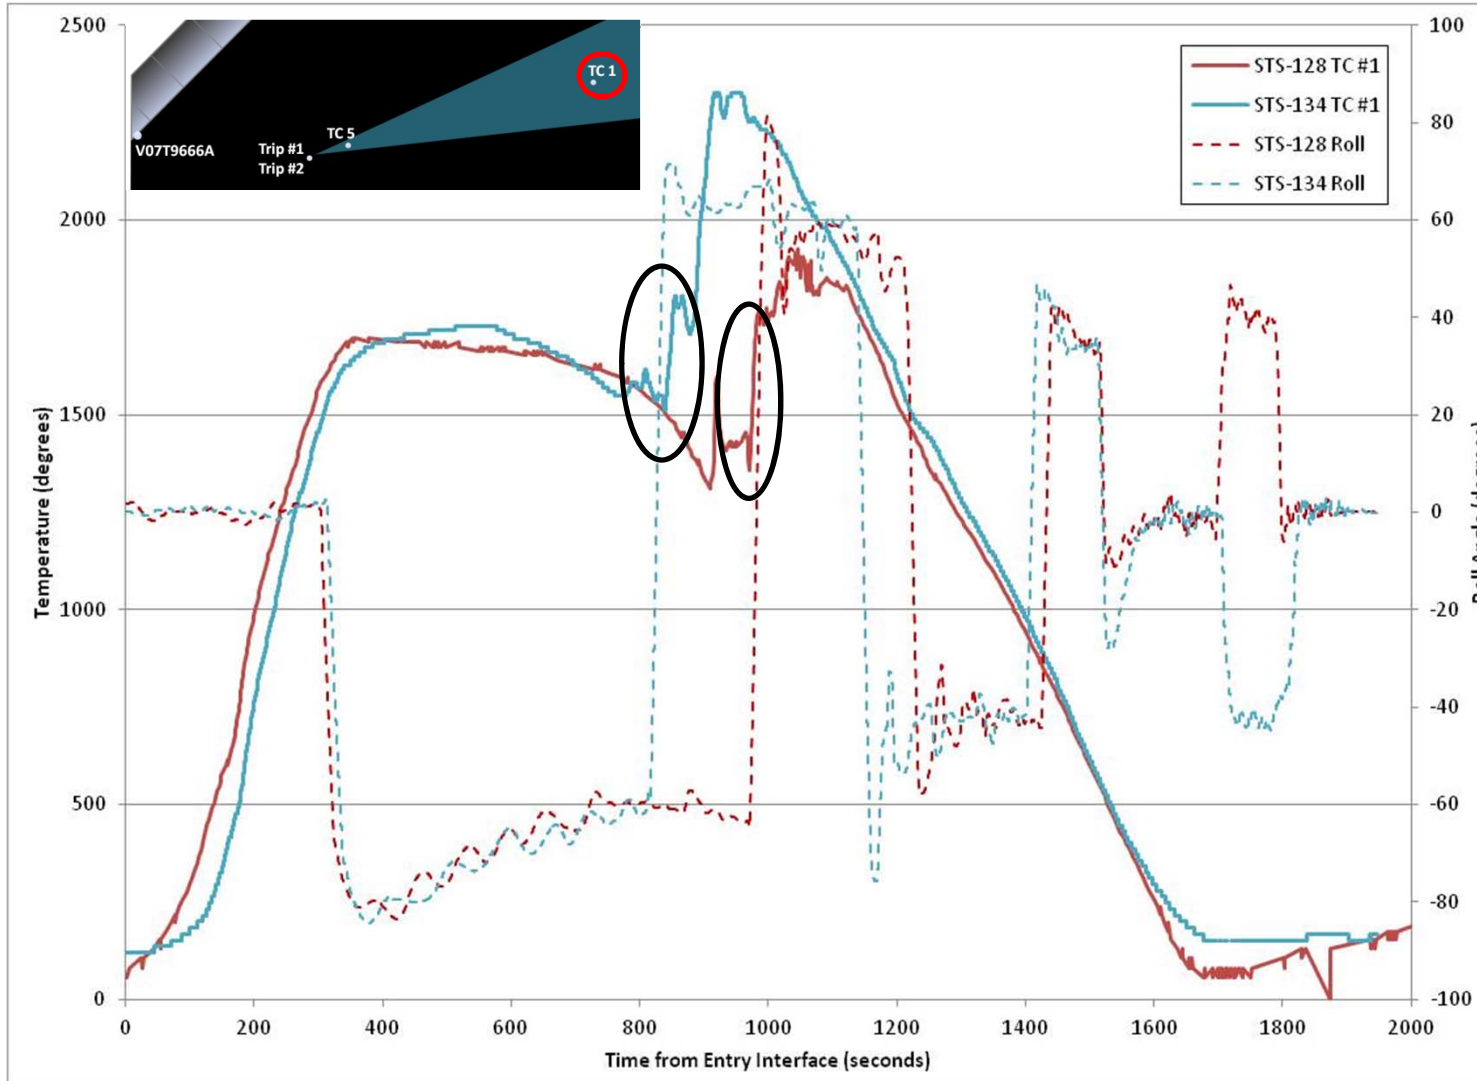
# STS-128 vs. STS-134 (TC1)

**Instrumentation Differences**  
STS-134 has Strain Gage Signal Conditioner

**1st Roll Reversal**  
Rapid increase for both flights

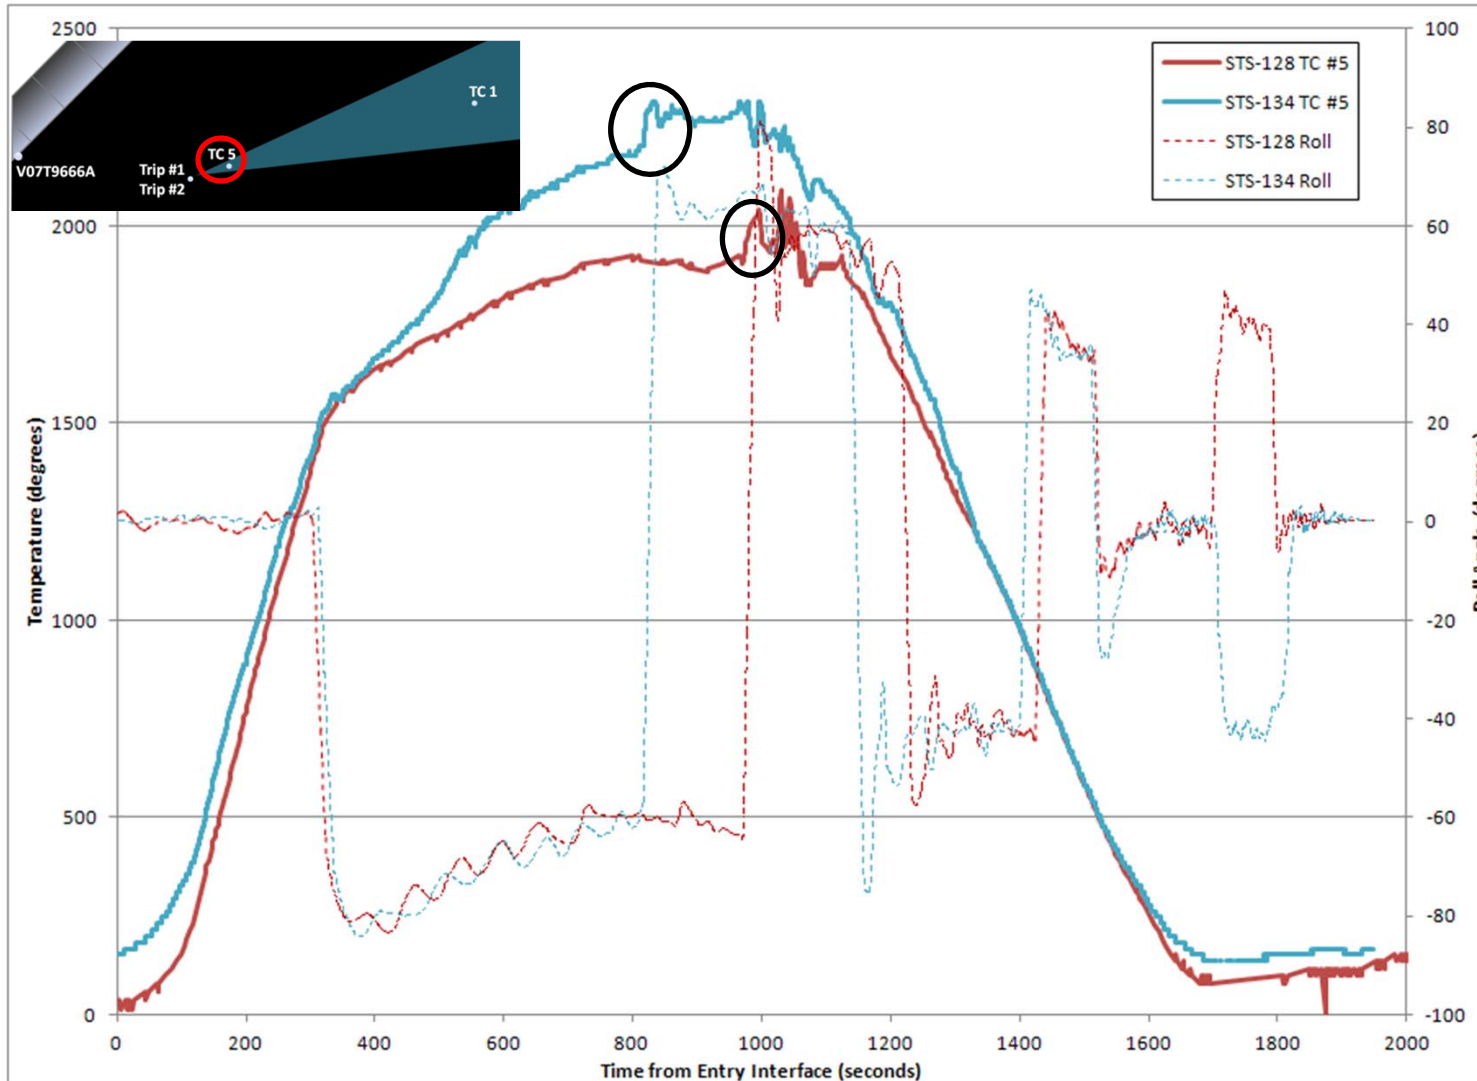
# STS-128 vs. STS-134 (TC5)

- STS-134 has
- Strain Gage Signal Conditioner
  - S-Turn
  - Exposed TC Junction

Rapid increase  
(~100 deg)
