The International Space Station (ISS) Port 1 (P1) External Active Thermal Control System (EATCS) Ammonia Leak

Darnell T. Cowan, Timothy A. Bond
and Jordan L. Metcalf
NASA Lyndon B. Johnson Space
Center (JSC)

Thermal & Fluids Analysis Workshop
TFAWS 2019
August 26-30, 2019
NASA Langley Research Center
Hampton, VA

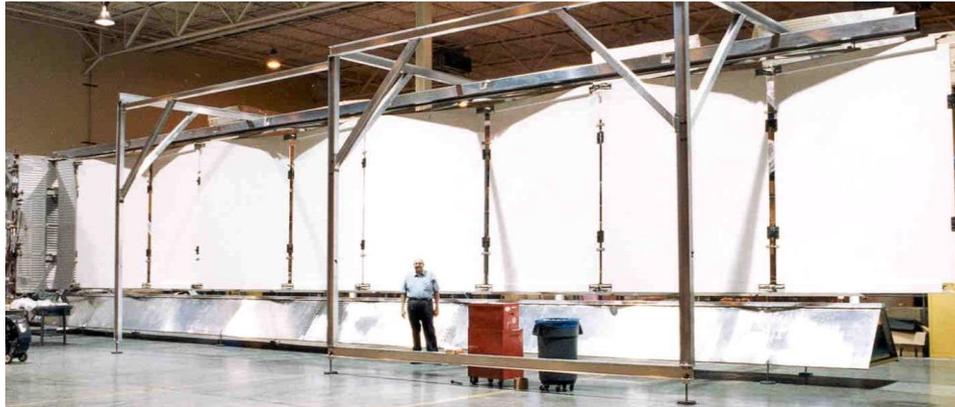
EATCS
Radiator

S1 EATCS

P1 EATCS

- EATCS - closed loop, single phase, mechanically pumped fluid system (two redundant loops)
- Heat Rejection Capability – up to 35 kW ($1.2E^5$ BTU/hr) per EATCS
- Starboard (S1) and Port (P1) EATCS were launched in 2002, filled with ammonia and activated in 2006

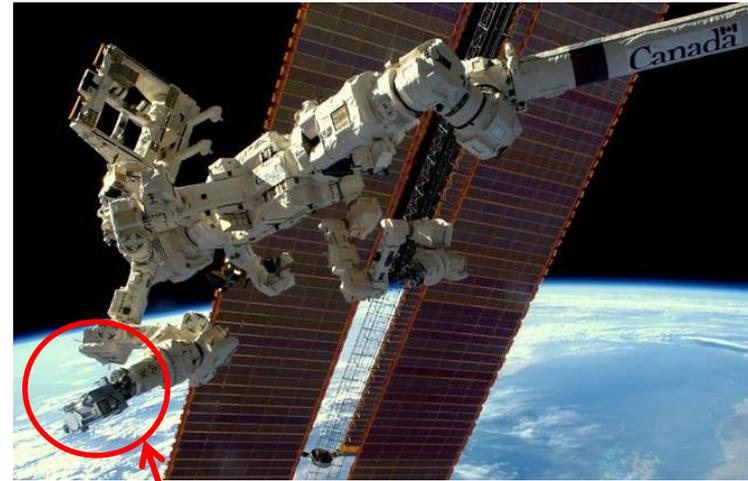
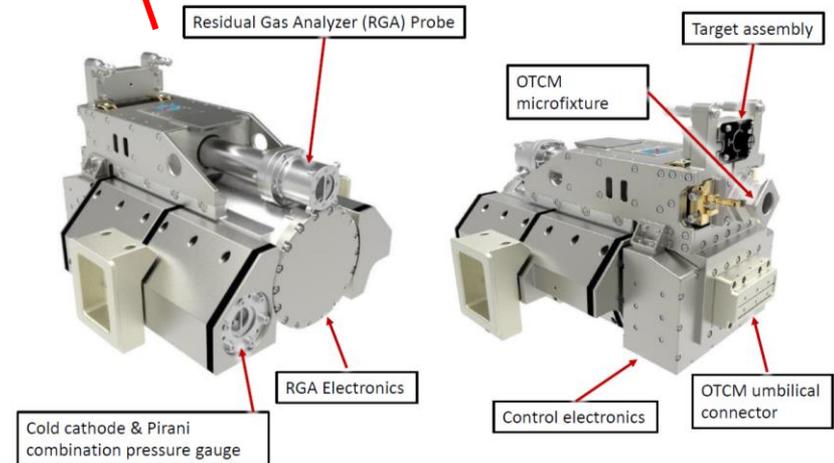
RELL Unit

- The Robotic External Leak Locator (RELL)!
- New tool built to work with ISS Robotic Arm
- Remotely detect and ID various gases, and measure their pressures in a vacuum
 - Detect molecules up to 100 amu
 - Cold Cathode Ion Gauge measures total pressure
 - Residual Gas Analyzer (mass spec) measures partial pressure
 - Pressure measurements are directional in space environment
- Launched in 2015
- Coincidentally, in time to help locate P1 EATCS leak

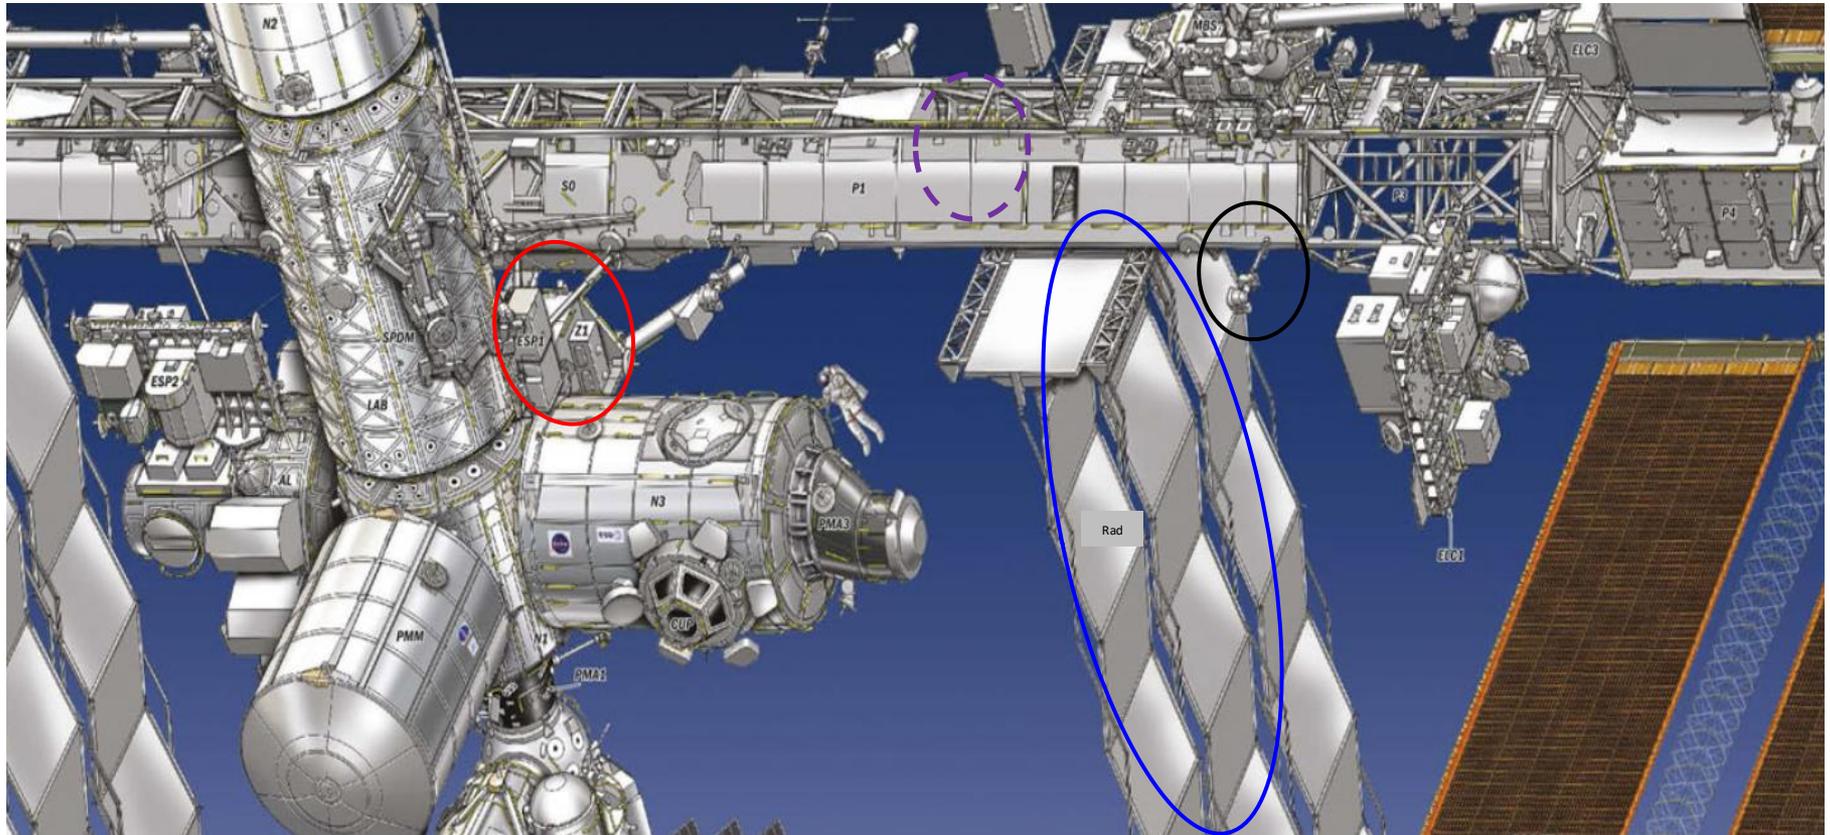
Possible White Flakes Sources Locations

- Unknown if the P1 EATCS ammonia leak and the white flakes were related

- P1 EATCS Radiators circled in blue, Z1 (decommissioned) and a spare Pump Flow Control Subassembly (PFCS) circled in red, P1 EHDC circled in black, ATA behind structure (dotted purple)⁹

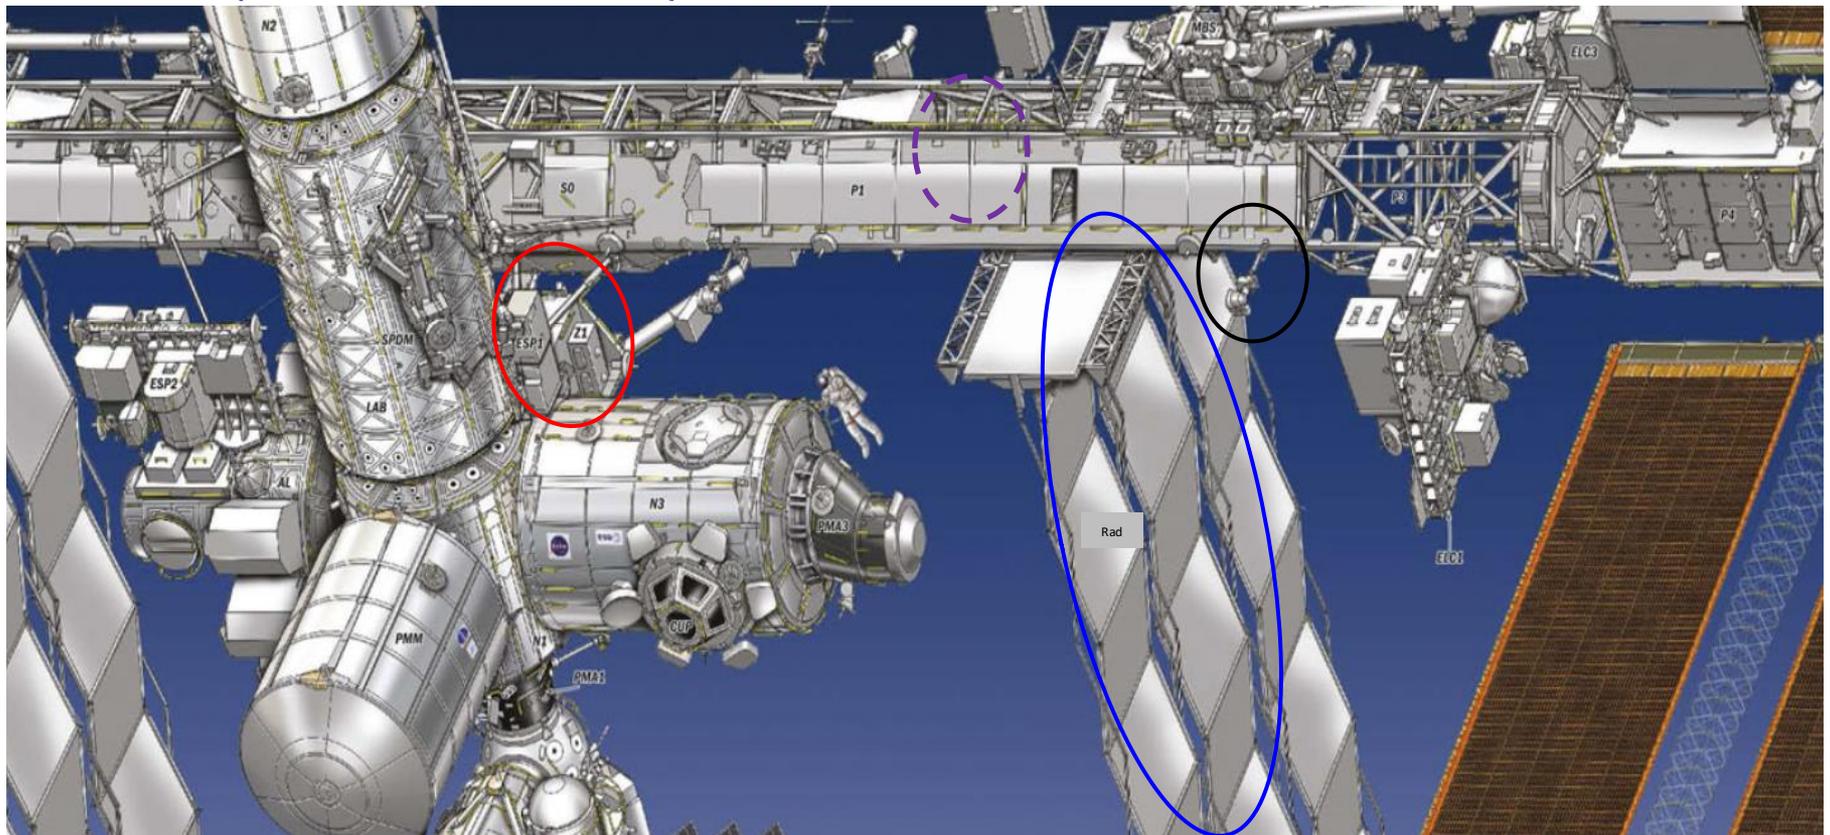
- P1 ISS EATCS Radiator Beam Valve Modules (RBVM)

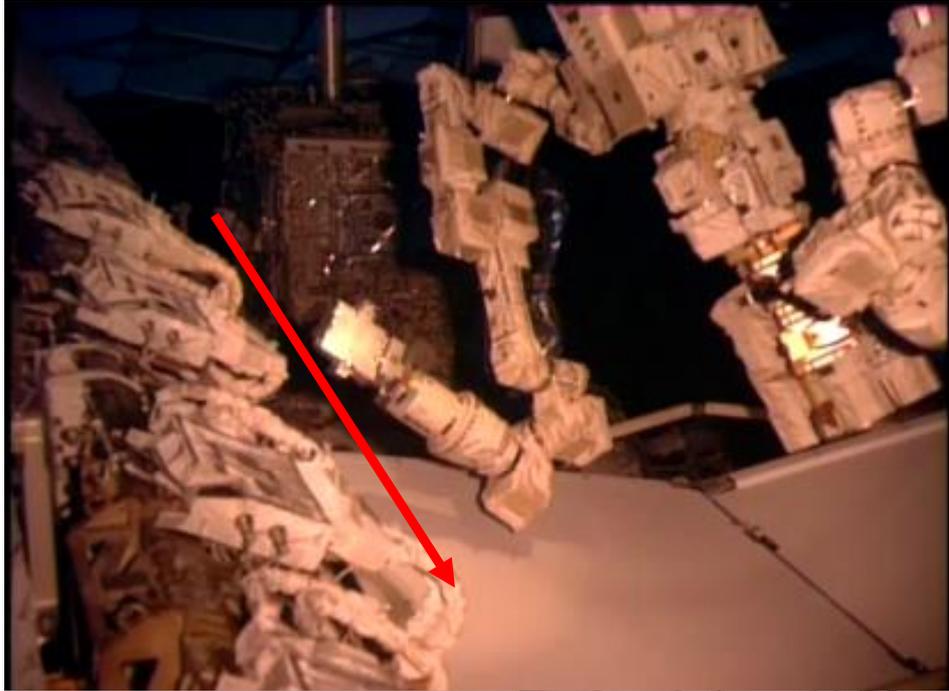
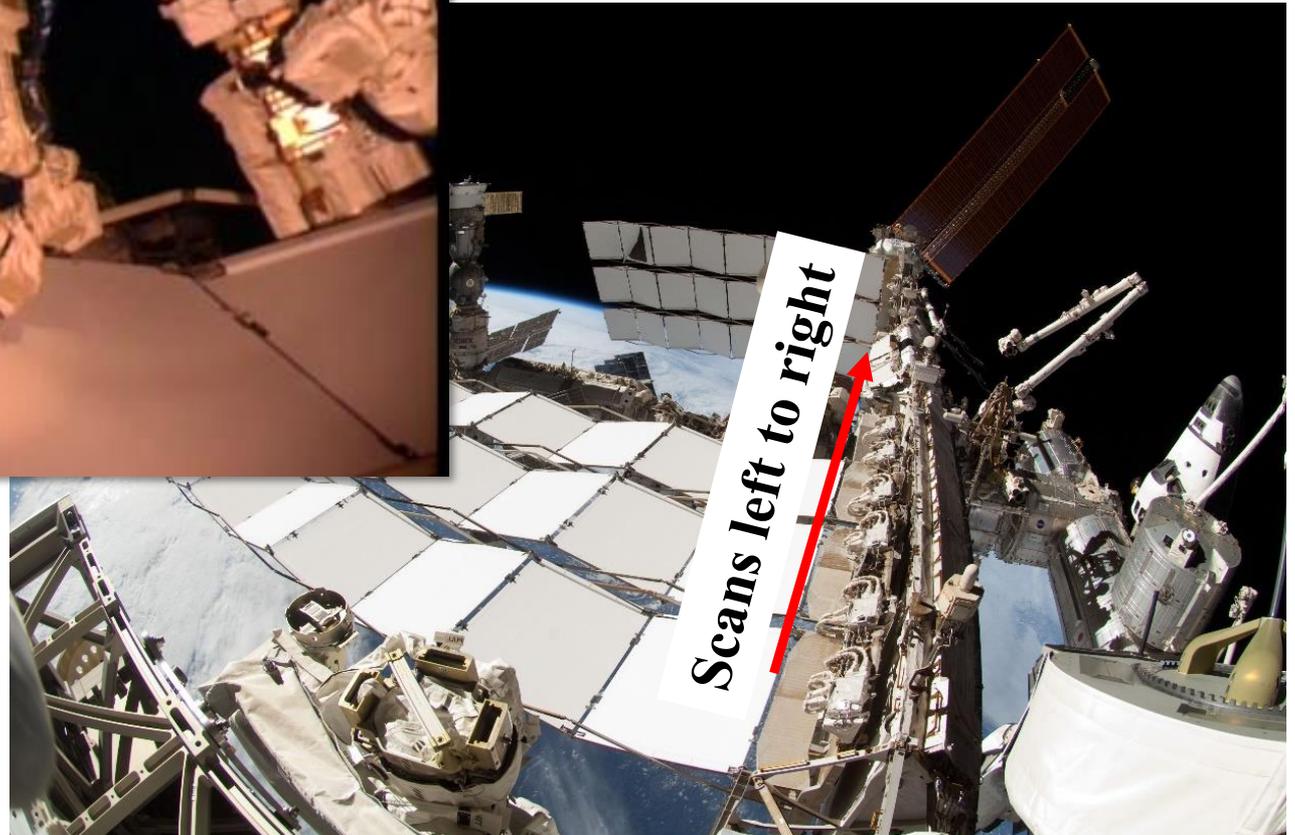
- Noticed total pressure spike at P1-3-2 RBVM on order of $\sim 5E^{-5}$ torr from the Cold Cathode Ion Gauge
- Low levels of ammonia around other RBVM $\sim 5E^{-7}$ torr
- Partial pressure from Residual Gas Analyzer correlated with ammonia

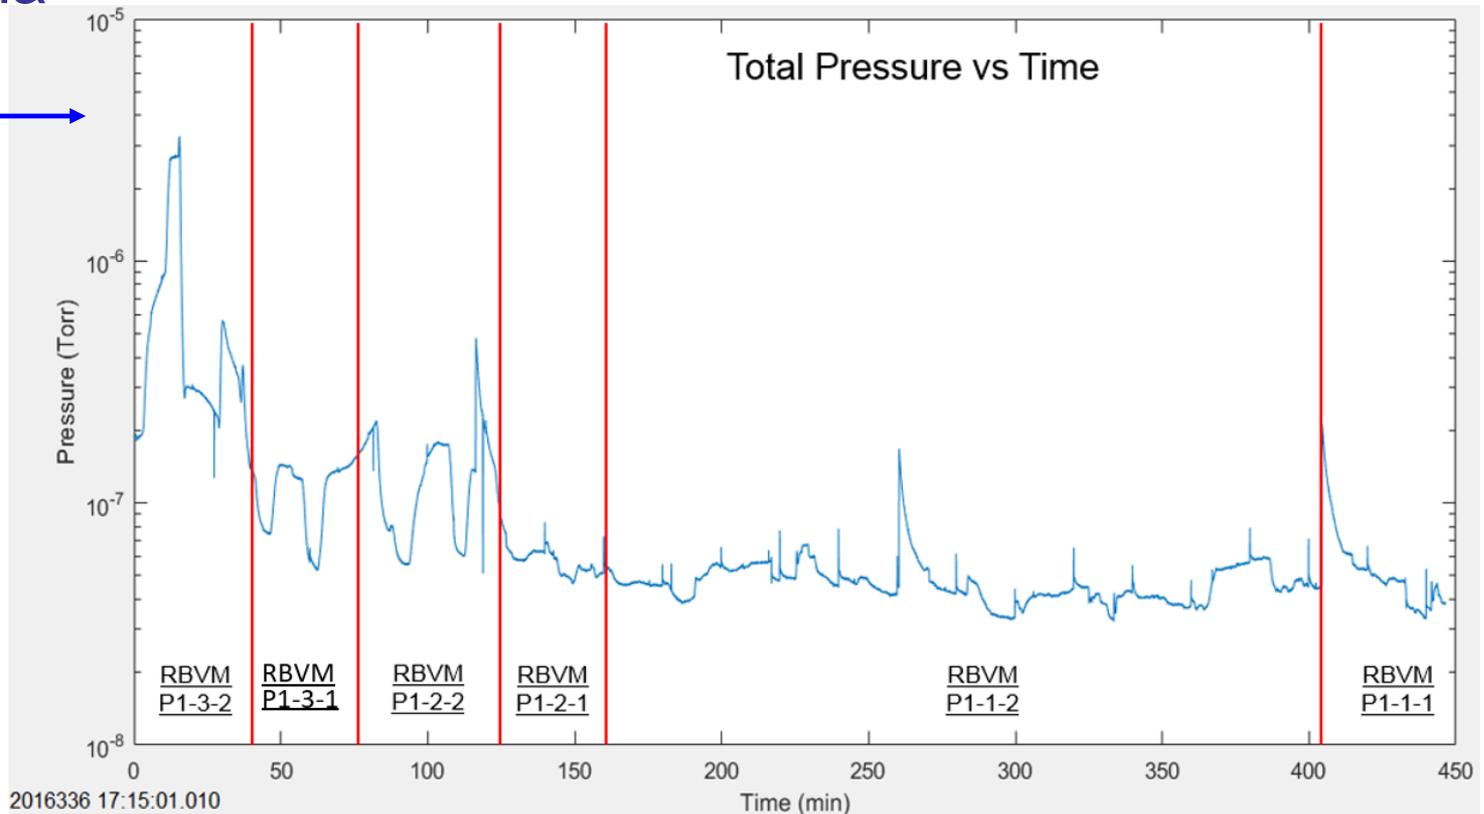
- Highest Pressures @ P1-3-2 RBVM to the radiator jumper hoses, and the hard lines underneath them
- Pressures E^{-5} torr \sim 50 lbm/year (22.6 kg/year)

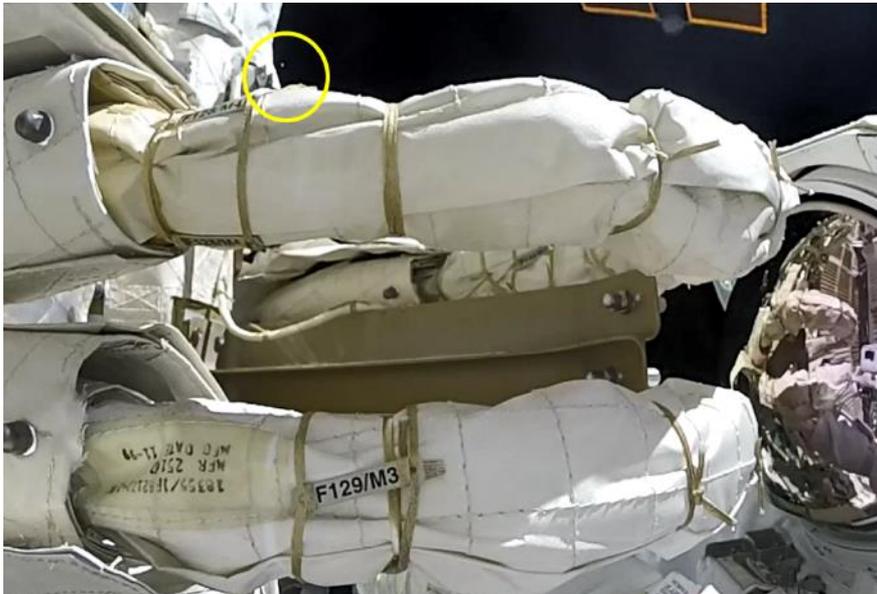
- Inspections of the RBVM jumpers hoses and system lines performed during an EVA in March 2017
- Nothing noteworthy observed from the crew
- Post EVA review, multiple white flakes seen from EVA GoPro video

- White flakes appearing to originate from the P1-3-2 RBMV to radiator hoses

- More confidence that the leak source was the P1-3-2 RBVM to the radiator hoses as we saw white flakes appearing to originate from them

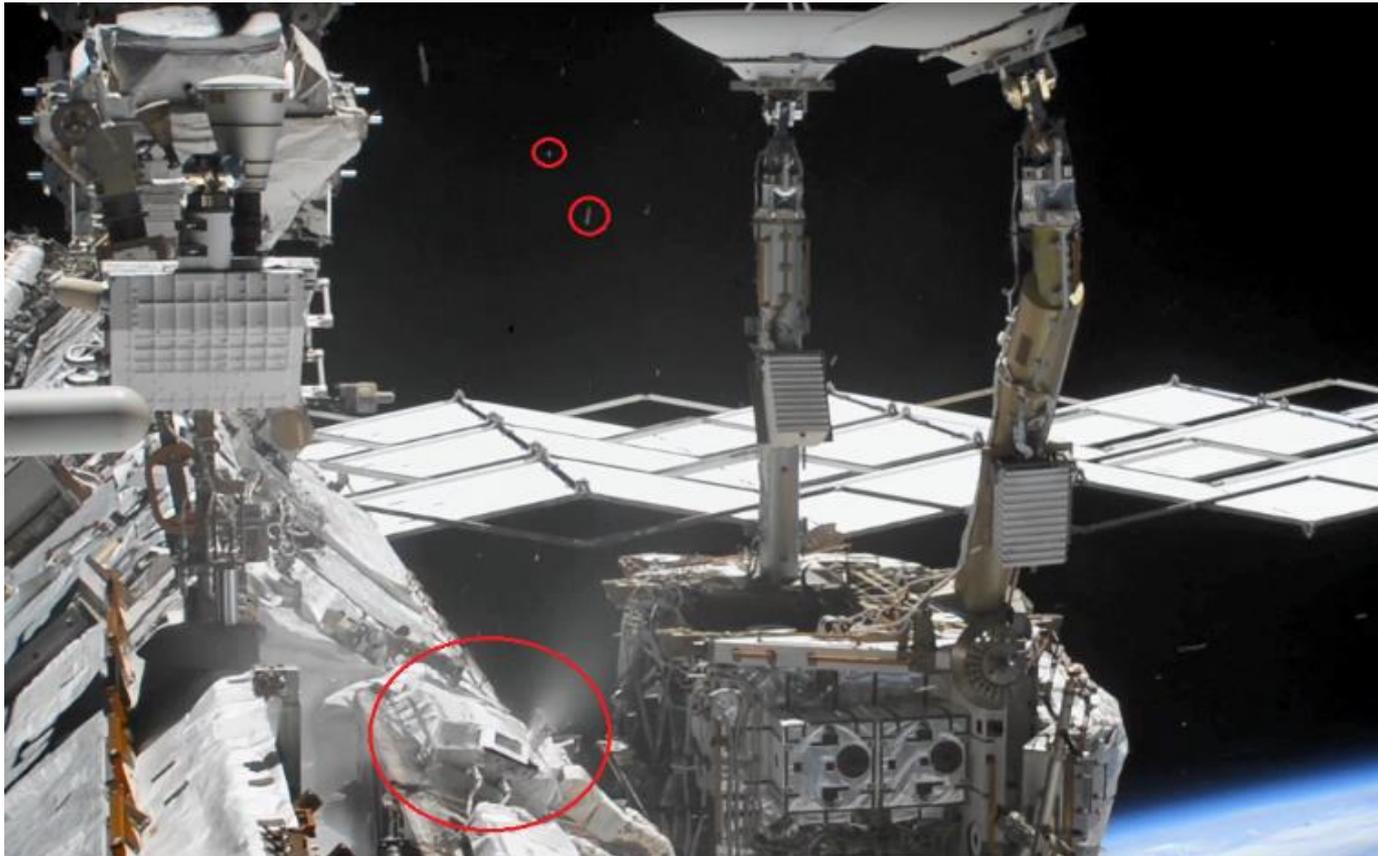
P1-3 Radiator Ammonia Vent

- Following the EVA in May 2017, ground teams remotely closed the P1-3-2 RBVM; isolating that radiator flow path
- Ammonia was then vented to space

- Determined that the P1 EATCS ammonia leak had stopped after several months of data trending

- White flakes have not been observed since

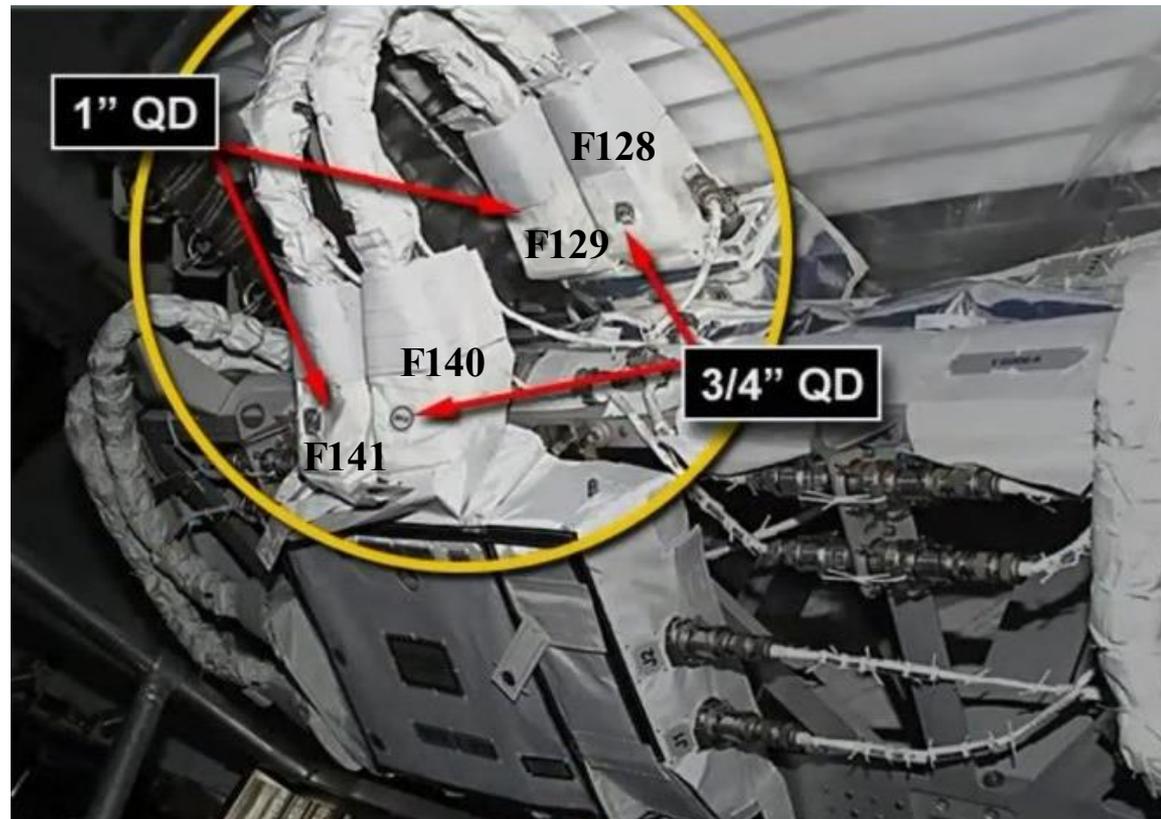
- Each RBVM has a 1" supply and 3/4" return hose connecting to a radiator
- Each hose contains two female Quick Disconnects (QD)
- Each QD contains multiple seals
- Some seals are not visible without significant QD disassembly

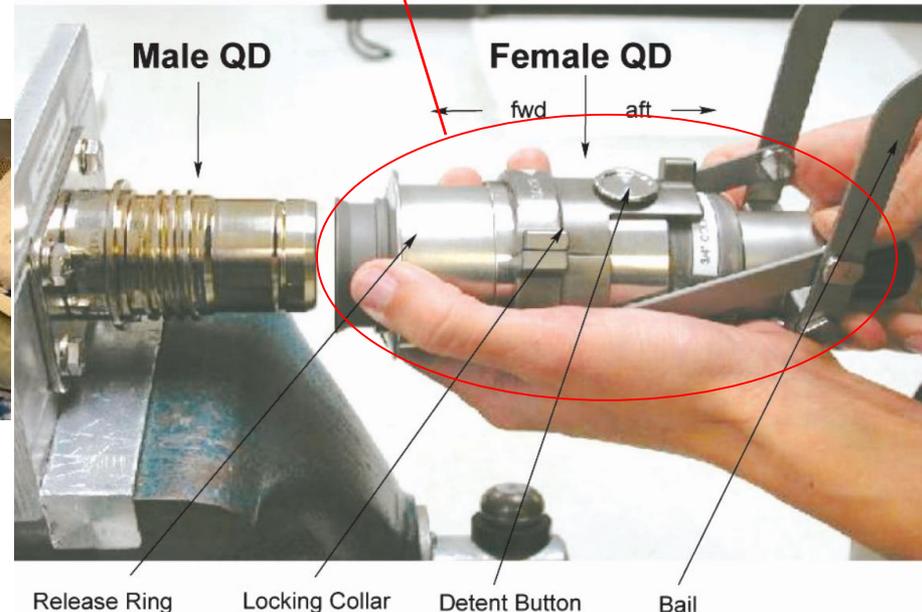
1" Supply Hose

- Visually the 1" supply hose looked good
- Barely failed the leakage requirement of 1 E^{-4} sccs of Helium at 500 psia (3447 kPa)
- Considered acceptable to be reused "as is", and returned to the ISS in April 2019

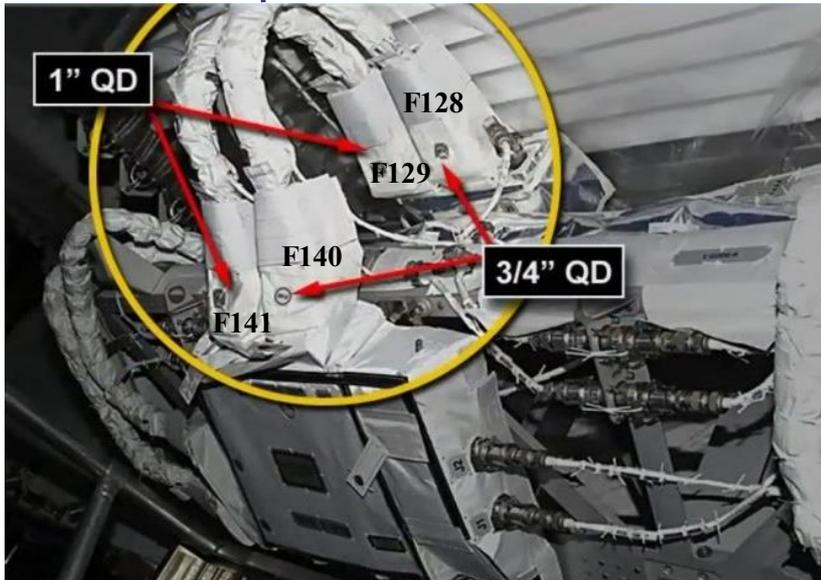
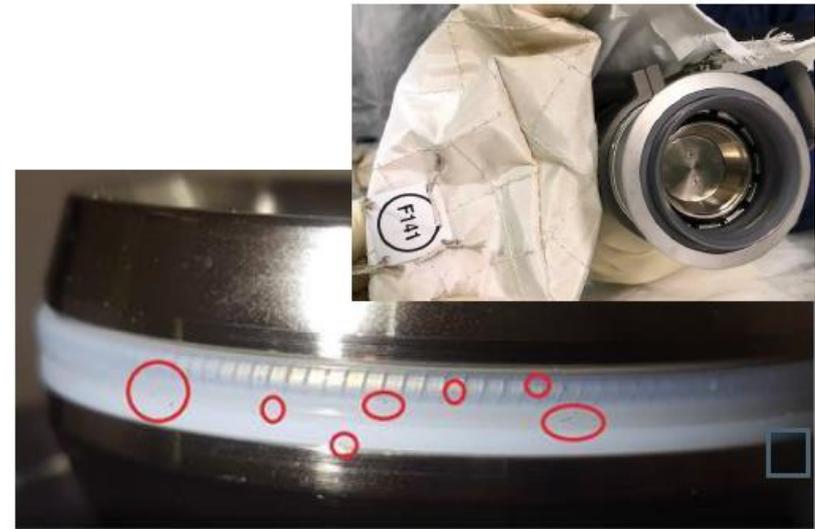
F141 QD secondary seal

- There were noticeable brown residue on the forward seals of the 3/4" return hose
 - Samples were taken to Materials and Process laboratory
 - Consisted on non-volatile residue (NVR), and the amount was consistent with what was allowed
- QD F140 failed the leakage requirement at $2.8E^{-3}$ sccs of Helium at 500psia (3447 kPa)
- QD F128 failed the leakage requirement at 1.91 sccs of Helium at 500 psia (3447 kPa)

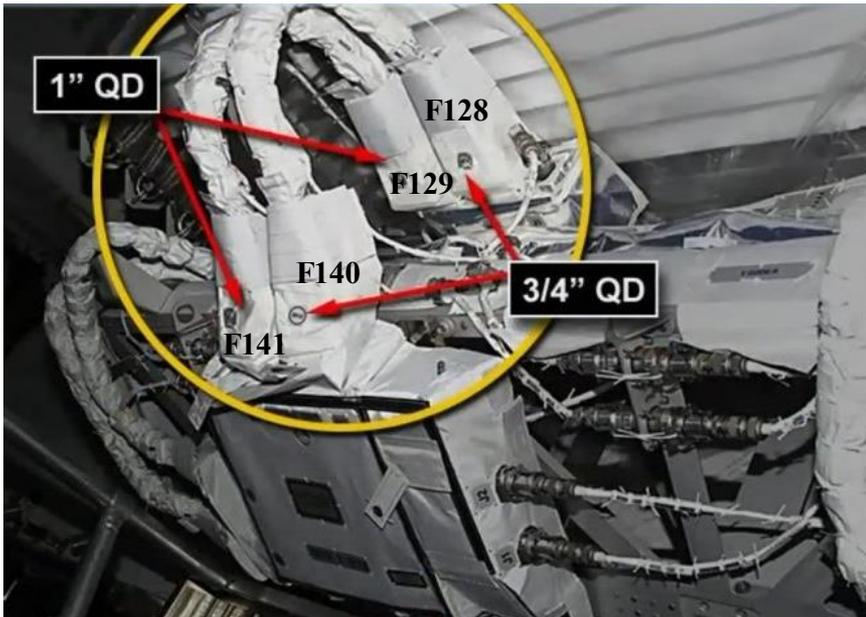
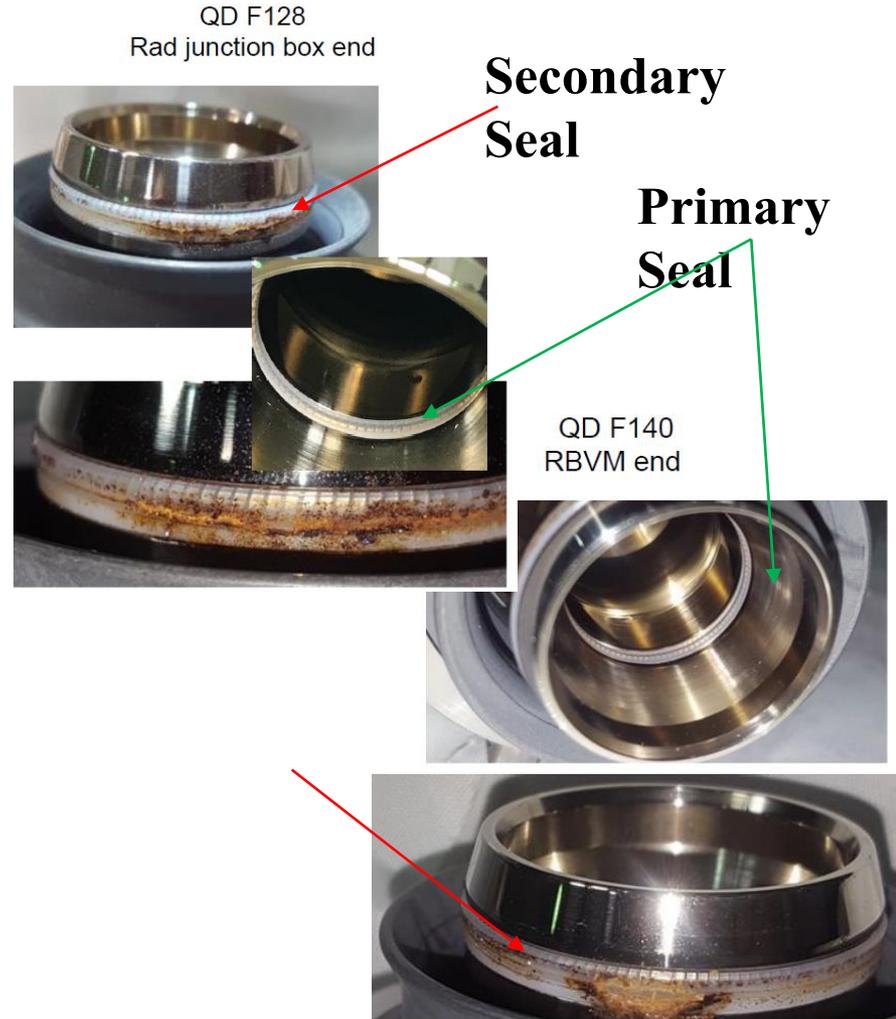
3/4" Return Hose

- Forward half failed the leakage requirement at $2.2E^{-1}$ sccs of Helium at 500 psia (3447 kPa)
- Aft half failed at 0.5 sccs of Helium @ 500 psia (3447 kPa)
- QD 128 and 140 were removed for additional TT&E
- New QDs were installed on the hose, and assembly launched to the ISS in April 2019

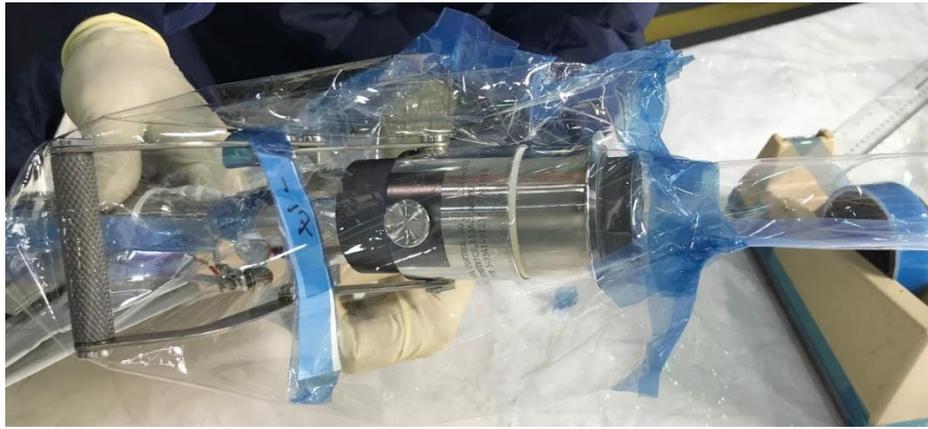
- QDs were sent to the vendor for disassembly to observe the aft seals
- No obvious signs of damage to either QDs
- Like the forward seals, significant amount of NVR was found on the aft seals of QD F128, which had the largest measurable leak rate
- Further analysis of the deposits and examination of surfaces is planned in the near future
