THERMAL VACUUM TESTING OF A MODIFIED COTS CAMERA FOR USE IN LUNAR ENVIRONMENTS

Parker D. Weide

NASA MSFC ES22

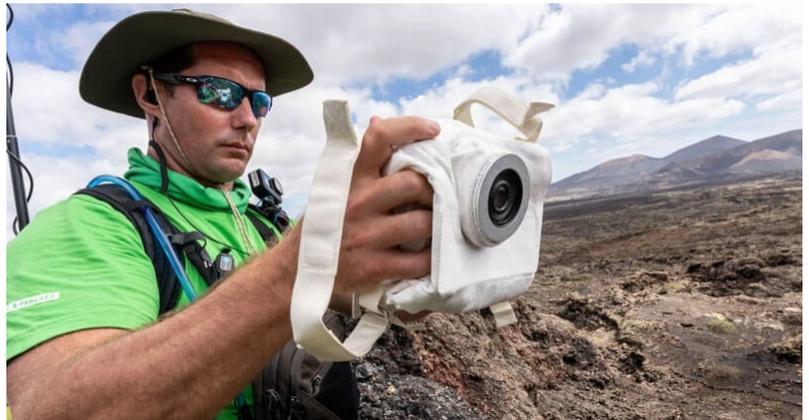
Figure 2: Thomas Pesquet Testing the HULC in its Thermal Blanket. (ESA, 2023)

Surrounding the camera during EVA missions is a thermal blanket. This blanket consists of a 7-layer MLI interior, encased in an Orthofabric shell. The blanket has an opening at the bottom, which is rolled to be closed, similar to a dry bag roll top enclosure system. The form factor of the blanket is custom fit to the geometry of the camera to provide an appropriately tight but not tensioned fit. Seams are sewn in a way to prevent dust passage, while also maintaining some level of

radiation protection. Hook and loop mount points are generally sewn only to the external layer of the Orthofabric, as well as any button markings, to reduce impacts on MLI performance due to layer compression.
