# DESIGN AND QUALIFICATION OF A HIGH TEMPERATURE MULTI-LAYER INSULATION BLANKET FOR THE EUROPA CLIPPER MISSION

Tyler Schmidt, Margarita Brandt, Hared Ochoa, Frank Kelly, Mark Duran  
Jet Propulsion Laboratory, California Institute of Technology

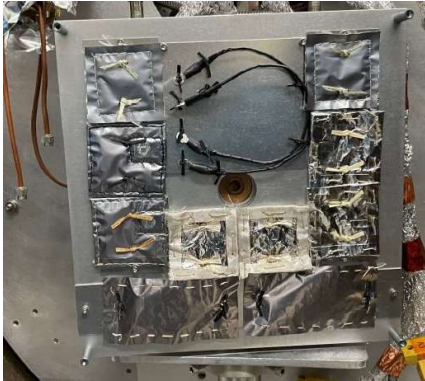
**Figure 2. Radiation test setup with sample blankets and ground straps.**

Radiation testing was completed for the Europa Clipper spacecraft blankets and ground straps in a separate effort with the JPL materials and processes group. Most of the high temperature candidate materials (ceramics, metals) described earlier are robust to Grad radiation levels. However, the polyimide layers and support materials (tape, sewing thread, lacing cord) must also remain intact. 2 inch by 2 inch square coupons of various MLI layups planned for Europa Clipper were subjected to thermal cycling and up to Grad TID radiation exposure (Figure 2). The standard 22 layer blanket design was thermally cycled ten times between ambient and +204 °C, radiation dosed in multiple stages in an inert environment to reach up to Grad TID on the external layer and Mrad regime on the internal layers, and then thermally cycled ten times between ambient and -236 °C. This order of operations was intentional to replicate flight (or at least as closely as possible). No significant discrepancies affecting fit, form, or function were observed. There was some creep of the StaMet coated black Kapton tape adhesive from underneath the substrate. The adhesive adhering the nomex scrim backing reinforcement to the StaMet coated black Kapton outer layer exhibited creep as well. These may have occurred

during the hot thermal cycles. These findings only apply to the standard MLI design used elsewhere on the spacecraft and not the high temperature design. Some fraying and outgassing of the lacing cord and thread was observed but the knots were retained (Figure 3). Neither of these was considered an issue for the MLI in flight.

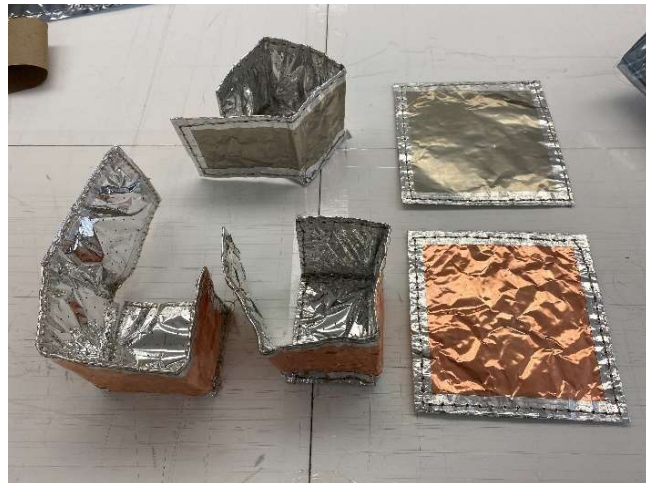
**Figure 7. Small scale manufacturing samples with copper and stainless steel foil outer layers and PTFE coated fiberglass/Inconel sewing thread.**

Environmental compliance aside, a design is not valuable if it cannot be manufactured. JPL has fabricated small, high temperature “patch” MLI with aluminum internal layers but never blankets with metallic outer layers. Small scale manufacturing tests were created as proofs of concept. Key concerns to address were sewability of the thread, likelihood of tear propagation, and suitability for a three dimensional shape. These proofs of concept (Figure 7) provided some early validation that such a design could be manufactured with minimal change to existing process. One immediate observation was that the metal layers tended to form and maintain creases. If a blanket were folded, the blanket held that shape. If the blanket were folded again to a different position, the blanket held that new shape. Tearing was not observed in the foil itself but was observed sometimes around holes created for lacing cord. An additional issue related to the creasing, especially for the copper outer layer samples, was that material tended to contract in-plane. This could lead to dimensional tolerancing issues on larger blankets that have cutouts or features in them. On a three dimensional blanket sample with 12 inch length, 0.75 inches of length was lost due to contraction of the material caused by handling.

The tension of the sewing machine was adjusted from what was typically used for blankets with polyester thread. Lightly lubricating the thread with isopropyl alcohol or ethyl alcohol was also helpful. Both of these were intended to keep the thread from breaking. Punching the lacing holes was harder as expected and effort seemed proportional to the number of metal foil layers in the layup.

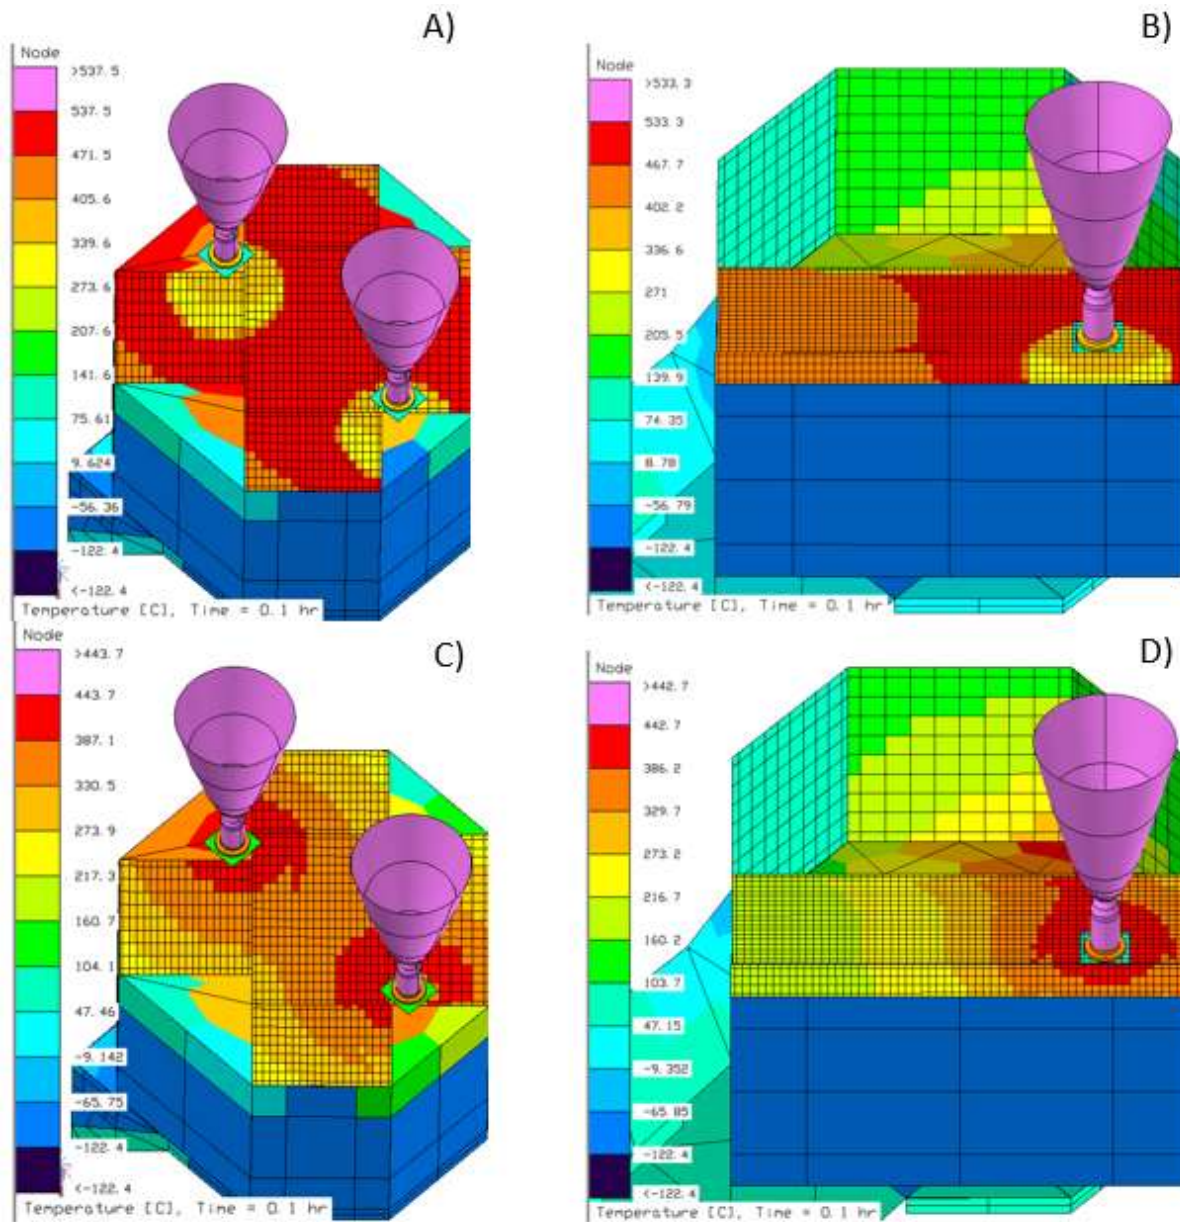
**Figure 8. Worst case hot temperature predictions for A) copper outer layer, axial side B) copper outer layer, roll side C) aluminized Nextel 312, axial side D) aluminized Nextel 312, roll side. For copper ( $\alpha/\epsilon = 10.6$ ), the nozzle shadow created a local cold spot since solar was the driving heat load. However, for aluminized Nextel 312 ( $\alpha/\epsilon = 0.8$ ), the area around the nozzle was hottest since the nozzle IR was the driving heat load.**

The worst case hot temperature predictions were 447, 463, and 538 °C for Nextel 312 (uncoated), titanium, and copper (end of life (EOL)) respectively. The difference in temperatures between roll and axial engine faces was only a few degrees Celsius for each

material. A specularity of 0.7 was also included as a sensitivity case (more applicable to metals) but only increased the temperatures by at most 2 °C. This seemed logical since the structure was primarily flat, convex surfaces with minimal opportunity for reflection to create hot spots. Interestingly, the location of the hottest temperature on the MLI varied based on the optical properties. For Nextel 312 and titanium, which have lower  $\alpha/\epsilon$ , the hot spot was next to the thruster nozzle since the absorbed IR heat from the nozzle was higher than the absorbed solar heat. However, for copper, which has a higher  $\alpha/\epsilon$  and a particularly low  $\epsilon$ , the temperature distribution was mostly uniform except for the annulus in the nozzle's shaded area since the absorbed solar heat was higher than the absorbed IR heat from the nozzle (Figure 8).

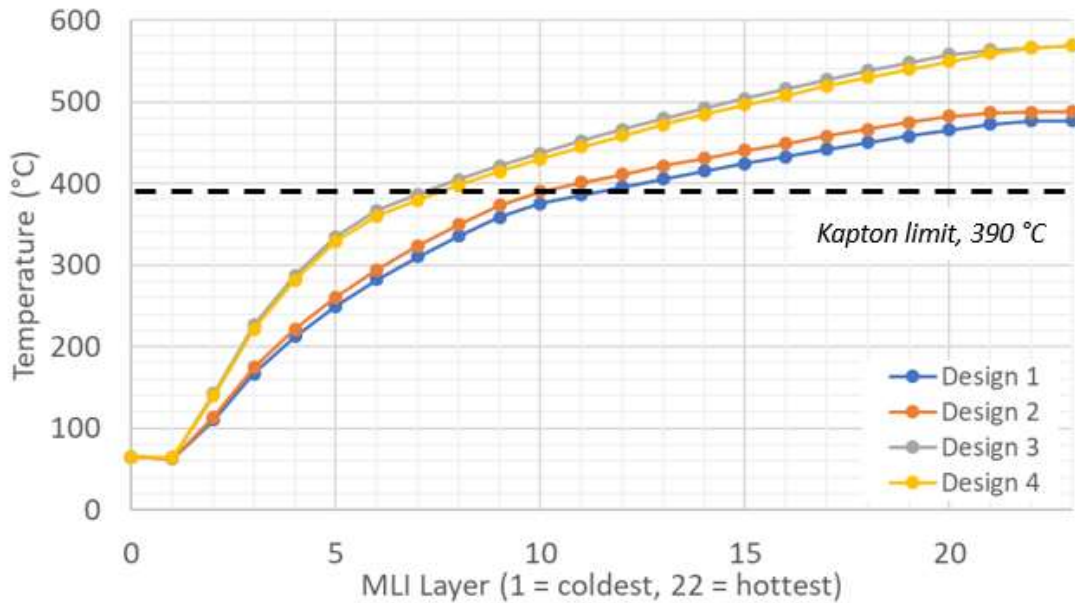
**Figure 9. Predicted temperatures for worst case hot IR qualification test (described later).**

At this point, an educated guess on the flight high temperature MLI layup was needed. The outer layer temperature prediction is an important starting point since it will be the highest of any in the blanket, but predictions of internal layer temperatures must be made to avoid damaging any vulnerable materials in the rest of the layup. A material cannot be located where temperatures will be above its melting point or the material (and possibly the blanket) will be compromised. Although the outer layer material could also be used for the internal layers, this would increase the blanket mass, thickness, and implementation complexity compared to materials used in a typical blanket. Aluminum foil was chosen as the "high temperature" internal layer and embossed VDA Kapton as the "low temperature" internal layer. Aluminum and Kapton are attractive for blanket construction due to JPL flight heritage, lower mass, and low infrared emissivity, which improves thermal performance (lower  $\epsilon^*$ ) of the blanket. Temperature predictions were made using both a three dimensional thermal model and hand calculations. The outer layer was set as a boundary temperature from the previous section plus some margin and the hardware was set to the max AFT (+65 °C). The total margin added to model predictions was 34 °C. This included 20 °C margin from allowable to qualification limits, 10 °C margin for hardware capability, and 4 °C for uncertainty in type K thermocouple readings expected at the target test temperatures. Then the temperatures of all layers were plotted and compared with the limit for Kapton (390 °C) to see where materials could be used in the layup with positive temperature margin remaining to the hardware capability (Figure 9).

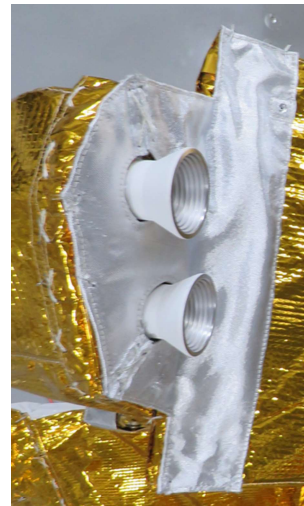
**Figure 14. High temperature MLI patch flown on AMR-SWOT.**

Further thermal analysis may be done to optimize the locations where the high temperature MLI is needed. A small 2D patch around the thruster engines may be sufficient if the high temperature on the MLI is very localized (as was seen with Nextel 312 and titanium). This high temperature patch approach has been implemented on several JPL flight projects where solar light can be concentrated on a small area in off-nominal attitudes. The most recent of these is the Advanced Microwave Radiometer instrument on the Surface Water Ocean Topography mission (Figure 14), which used a Nextel 312 outer layer (bare side viewing space) followed by aluminum and glass tissue separators for the first half of the blanket layup.

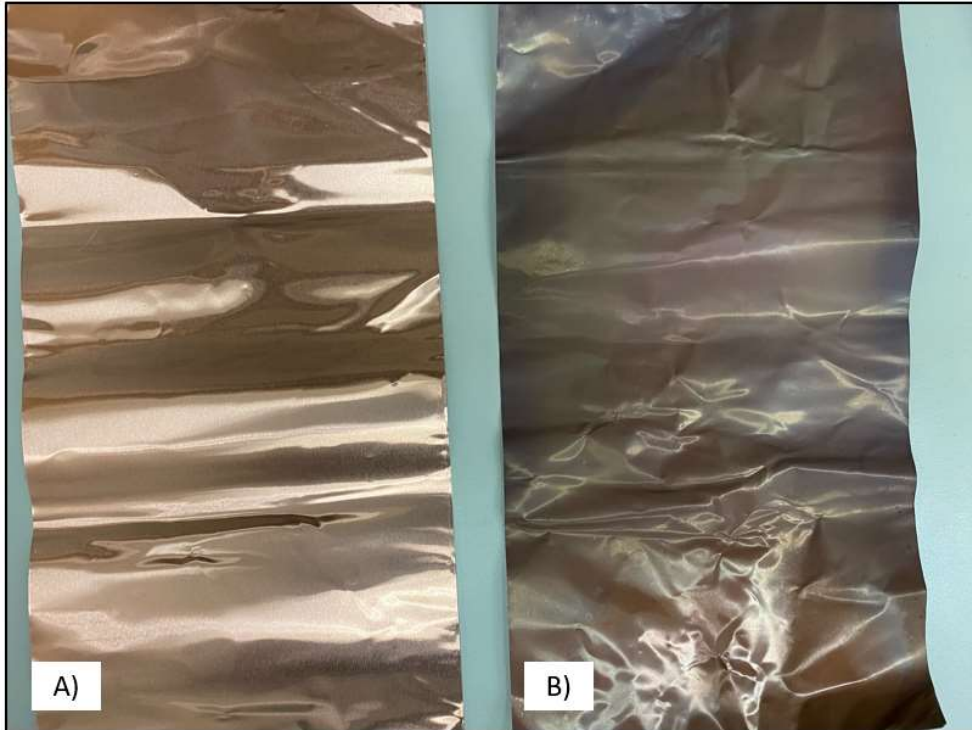
**Figure A1. Copper foil A) pre test B) post test.**

Copper foil was tested but not expected to be a concern for thermal survivability. However, copper can be reactive, so thermal optical property change was of interest. The copper showed visible darkening after the testing (Figure A1). The average pre-test properties were  $\alpha/\epsilon = 0.141/0.010 (=14.1)$ ; average post-test properties were  $\alpha/\epsilon = 0.735/0.068 (=10.6)$ . This large of a change was not expected and could be due to either the temperature exposure, impurities in the argon gas, or both. Copper is susceptible to oxidation at higher temperatures, so oxygen in the chamber may be a potential cause for the change.

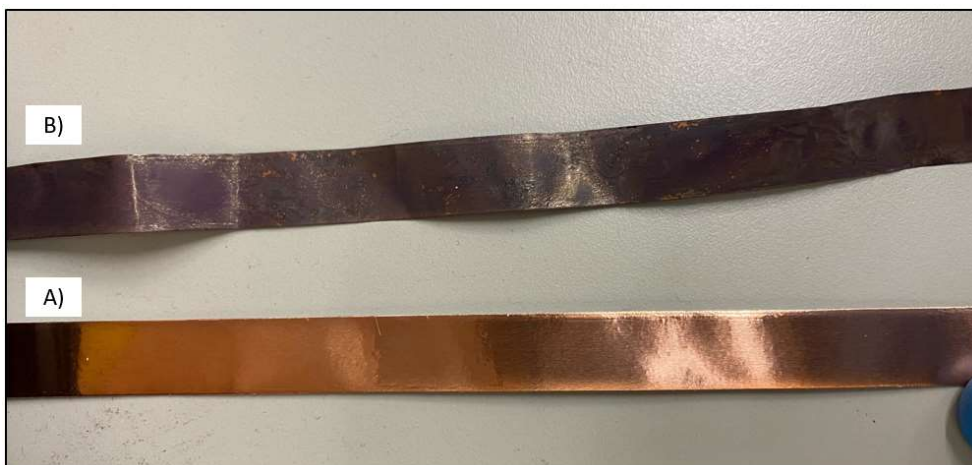
**Figure A2. Copper tape A) pre test B) post test.**

Not to be forgotten, the edge tape, sewing thread, and lacing cord must also survive the same environment as the outer layer material. The backing adhesive was no longer present on the copper foil tape, indicating that the material would no longer function as a tape (Figure A2). However, the material would be stitched to the blanket with sewing thread, so the remaining copper substrate would still be able to maintain the bound edges. The lacing cord was darker and more flexible (Figures A5, A6). The outer portion of the sewing thread was visibly darker and the thread was stiffer (Figure A7). However, the thread retained integrity and the Inconel wire insert was unchanged. It was expected that the PTFE coating on the lacing cord and thread would decompose at these temperatures since its melting temperature was lower than 600 °C. The thread generated some particulate contamination when handled after exposure. However, this is not a concern for the mission since the thread will not be in this condition until flight, at which point no handling will occur to create particulation. Related to the outgassing requirement, the contamination control team determined there was not a viable transport mechanism in this case to sensitive hardware to negatively impact the mission.
