THERMAL ANALYSIS IN SUPPORT OF THE BOOSTER SEPARATION MOTOR CRACK INVESTIGATION

ABSTRACT

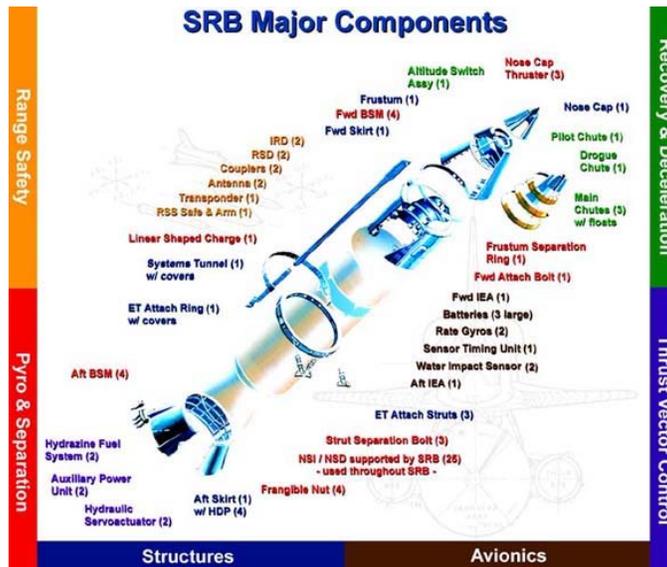
Figure 2: SRB Components Showing Location of BSMs

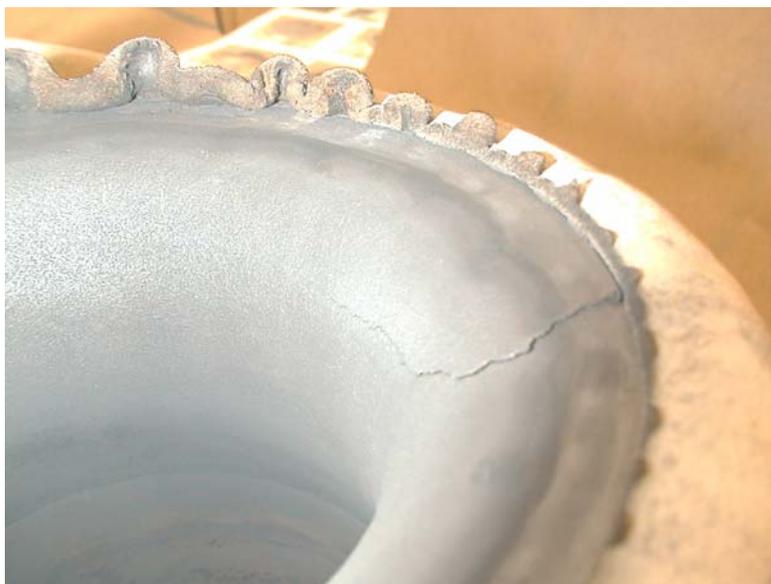
These motors are manufactured by Pratt & Whitney's Chemical Science's Division (CSD) near San Jose, California. A lot of BSMs consist of 160 motors manufactured with similar characteristics. From each lot, two motors are chosen for Lot Acceptance Tests (LAT). The motors are preconditioned hot and cold, 120F and 30F, and fired. The purchase of the lots is dependent on the results of the LAT. Testing of the lot designated ABM was performed in December 2000. Since it was near the Christmas holiday, the two BSMs were packed into crates and left under a overhang. In early January, the motors were removed and subjected to the post-test inspection. At that time it was noticed that the forward end of the graphite throat had a crack.

Figure 3: Crack in Graphite Throat

During the history of the BSM program, a crack had never been detected in a BSM throat. Since this was an out-of-family occurrence, an anomaly investigation team was formed. (Further investigation revealed that this might not have been as rare as was thought. Even though eight BSMs fly on each SRB, 16 per flight, very few had been subjected to the type of inspection that would have seen such a crack. Most of the throats on the aft BSMs are shoved into the BSM case at splashdown and are damaged beyond the point of reasonable inspection. The typical inspection routine for the forward BSMs was a simple visual inspection to ensure there was no catastrophic failure or out-of-family erosion of the throat. BSMs from the first three shuttle flights, the first two post-Challenger flights and every one of the LAT BSMs were inspected in-depth.)
